# Access Compliance Report

## Public Rights-of-Way

### (Curb Ramps)

Intersection ID: 43979	Main Street: SHARON_VIEW_RD	Cross Street: PARK_PHILLIPS_CT	Location: NE
ADA ID: ABE13C7D0FB4	Ramp Type: BlendTrans2	Initial Pass/Fail: Fail	Overall Compliance: No
Severity Score: 1.25			
Codes/Mitigation Info/Possible Solution		Field Measurements/Component Compliance

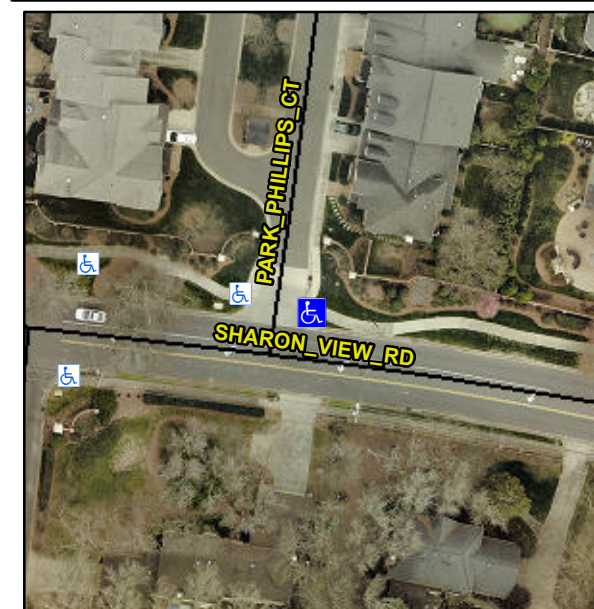
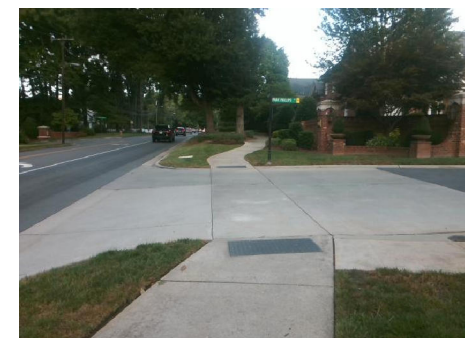
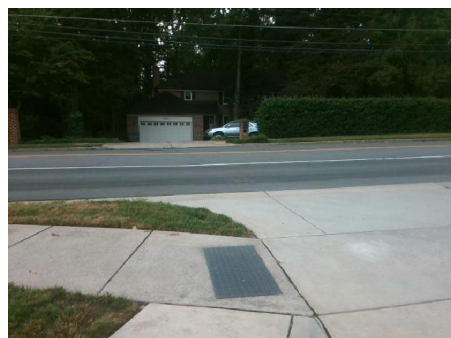
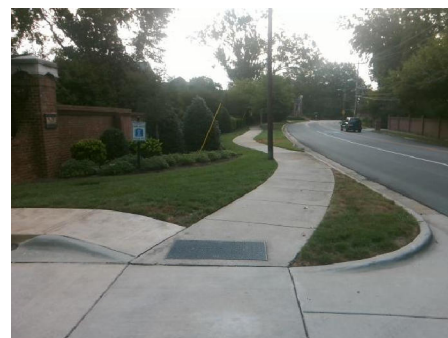
**R304.5.3**

Compliance	Description	Data	Compliance	Description	Data
N/A	Ramp Length (in)	65.0	Yes	BlendTrans Slope (%)	0.1
Yes	Ramp Width (in)	48.0	No	BlendTrans XSlope (%)	3.1
N/A	Flare Type LT	N/A	N/A	Flare Type RT	N/A
N/A	Flare Slope LT (%)	N/A	N/A	Flare Slope RT (%)	N/A
N/A	Flare Traversable LT?	N/A	N/A	Flare Traversable RT?	N/A
N/A	Landing Length (in)	N/A	N/A	DWS Provided?	N/A
N/A	Landing Width (in)	N/A	N/A	DWS Contrast?	N/A
N/A	Landing Slope (%)	N/A	N/A	DWS Length (in)	N/A
N/A	Landing X Slope (%)	N/A	N/A	DWS Full Width?	N/A
N/A	Landing Curb? (Y/N)	N/A	N/A	DWS Offset (in)	N/A
N/A	Shared Landing?	N/A			
N/A	Gutter Ponding?	N/A	N/A	Gutter Slope (%)	N/A
N/A	Gutter Lip Ht (in)	N/A	N/A	Gutter X Slope (%)	N/A
N/A	Painted X Walk1?	No	N/A	Painted X Walk2?	N/A
	X Walk 1 Direction	To W		X Walk 2 Direction	N/A
	X Walk 1 Width (in)	N/A		X Walk 2 Width (in)	N/A
	X Walk 1 Slope (%)	2.8		X Walk 2 Slope (%)	N/A
	X Walk 1 X Slope (%)	2.2		X Walk 2 X Slope (%)	N/A

N/A	Ramp inside XWalk1?	N/A	N/A	Ramp inside XWalk2?	N/A
	Road Slope (%)	2.2		Clear Space?	N/A
	Road X Slope (%)	2.8	N/A	Clear Space to XWalk (in)	N/A
N/A	Any Obstructions?	N/A	N/A	Storm Grate/Utility Hazard?	N/A
	Obstruction Type			Storm Grate/Utility Type	
		N/A			N/A
			Yes	Surface Condition? (G/P)	Good
			N/A	Curb Slope (%)	0.9

**Remove & Replace Curb Ramp With Two New Directional Ramps or Equivalent.**
