Access Compliance Report

Public Rights-of-Way

(Curb Ramps)

Intersection ID: 46754	Main Street: SUPERIOR_ST	Cross Street: TAHOE_DR	Location: S
ADA ID: AC1CB8D8A6C8	Ramp Type: BlendTrans1	Initial Pass/Fail: Fail	Overall Compliance: No
		Severity Score: 10

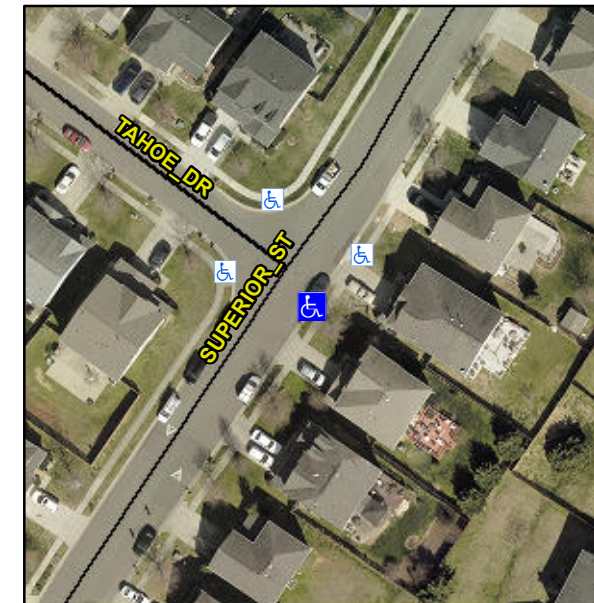
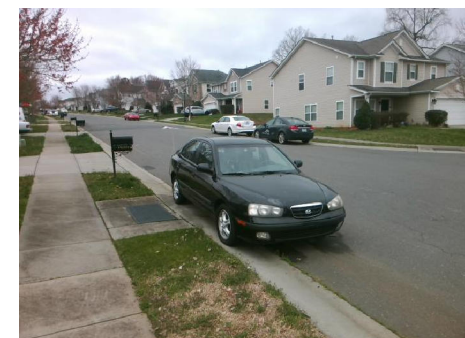
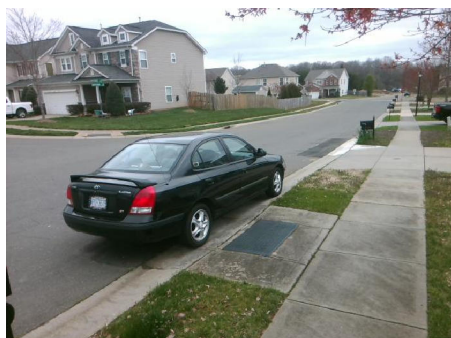
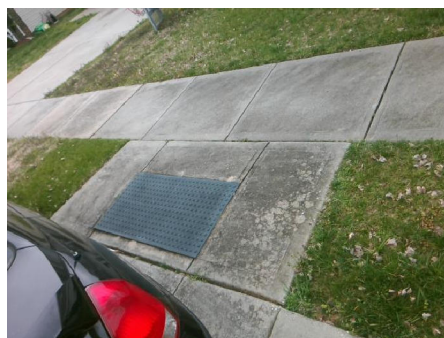
Compliance	Description	Data	Compliance	Description	Data
N/A	Ramp Length (in)	47.0	Yes	BlendTrans Slope (%)	4.0
No	Ramp Width (in)	47.0	Yes	BlendTrans XSlope (%)	4.7
N/A	Flare Type LT	N/A	N/A	Flare Type RT	N/A
N/A	Flare Slope LT (%)	N/A	N/A	Flare Slope RT (%)	N/A
N/A	Flare Traversable LT?	N/A	N/A	Flare Traversable RT?	N/A
N/A	Landing Length (in)	N/A	N/A	DWS Provided?	N/A
N/A	Landing Width (in)	N/A	N/A	DWS Contrast?	N/A
N/A	Landing Slope (%)	N/A	N/A	DWS Length (in)	N/A
N/A	Landing X Slope (%)	N/A	N/A	DWS Full Width?	N/A
N/A	Landing Curb? (Y/N)	N/A	N/A	DWS Offset (in)	N/A
N/A	Shared Landing?	N/A			
N/A	Gutter Ponding?	N/A	N/A	Gutter Slope (%)	N/A
N/A	Gutter Lip Ht (in)	N/A	N/A	Gutter X Slope (%)	N/A
N/A	Painted X Walk1?	No	N/A	Painted X Walk2?	N/A
	X Walk 1 Direction	To NW		X Walk 2 Direction	N/A
	X Walk 1 Width (in)	N/A		X Walk 2 Width (in)	N/A
	X Walk 1 Slope (%)	2.1		X Walk 2 Slope (%)	N/A
	X Walk 1 X Slope (%)	5.4		X Walk 2 X Slope (%)	N/A

N/A	Ramp inside XWalk1?	N/A	N/A	Ramp inside XWalk2?	N/A
	Road Slope (%)	5.4		Clear Space?	N/A
	Road X Slope (%)	2.1	N/A	Clear Space to XWalk (in)	N/A
N/A	Any Obstructions?	N/A	N/A	Storm Grate/Utility Hazard?	N/A
	Obstruction Type			Storm Grate/Utility Type	
		N/A			N/A
			Yes	Surface Condition? (G/P)	Good
			N/A	Curb Slope (%)	1.4

Remove & Replace Curb Ramp With Two New Directional Ramps or Equivalent.
