# Access Compliance Report

## Public Rights-of-Way

### (Curb Ramps)

Intersection ID: 10028420	Main Street: HIGHGROVE_ST	Cross Street: N/A	Location: SE
ADA ID: AC1FB59A6B97	Ramp Type: PerpDiag	Initial Pass/Fail: Fail	Overall Compliance: No
		Severity Score: 22.5

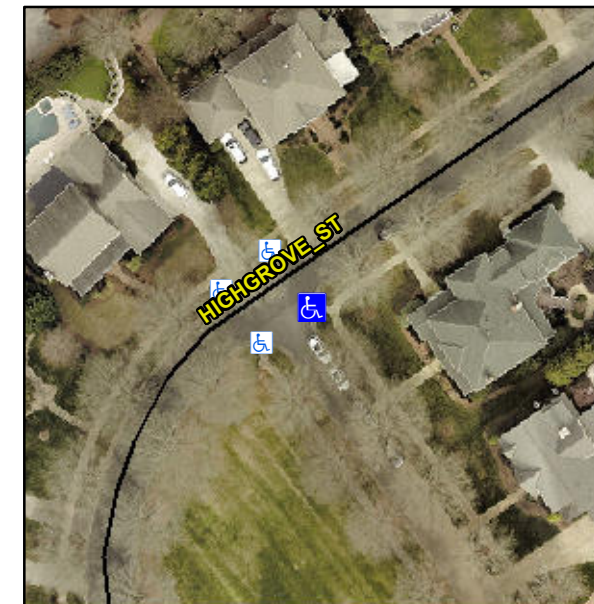
Compliance	Description	Data	Compliance	Description	Data
N/A	Ramp Length (in)	102.0	No	Ramp Slope (%)	8.7
No	Ramp Width (in)	45.0	No	Ramp XSlope (%)	3.1
N/A	Flare Type LT	N/A	N/A	Flare Type RT	N/A
N/A	Flare Slope LT (%)	N/A	N/A	Flare Slope RT (%)	N/A
N/A	Flare Traversable LT?	N/A	N/A	Flare Traversable RT?	N/A
N/A	Landing Length (in)	N/A	N/A	DWS Provided?	N/A
N/A	Landing Width (in)	N/A	N/A	DWS Contrast?	N/A
N/A	Landing Slope (%)	N/A	N/A	DWS Length (in)	N/A
N/A	Landing X Slope (%)	N/A	N/A	DWS Full Width?	N/A
N/A	Landing Curb? (Y/N)	N/A	N/A	DWS Offset (in)	N/A
N/A	Shared Landing?	N/A			
N/A	Gutter Ponding?	N/A	N/A	Gutter Slope (%)	N/A
N/A	Gutter Lip Ht (in)	N/A	N/A	Gutter X Slope (%)	N/A
N/A	Painted X Walk1?	No	N/A	Painted X Walk2?	No
	X Walk 1 Direction	To NW		X Walk 2 Direction	To SW
N/A	X Walk 1 Width (in)	N/A	N/A	X Walk 2 Width (in)	N/A
	X Walk 1 Slope (%)	3.8		X Walk 2 Slope (%)	6.0
	X Walk 1 X Slope (%)	5.5		X Walk 2 X Slope (%)	1.5

N/A	Ramp inside XWalk1?	N/A	N/A	Ramp inside XWalk2?	N/A
	Road Slope (%)	1.8	N/A	Clear Space?	N/A
	Road X Slope (%)	3.9	N/A	Clear Space to XWalk (in)	N/A
N/A	Any Obstructions?	N/A	N/A	Storm Grate/Utility Hazard?	N/A
	Obstruction Type			Storm Grate/Utility Type	
		N/A			N/A
			Yes	Surface Condition? (G/P)	Good

**Remove & Replace Curb Ramp With Two New Directional Ramps or Equivalent.**

**R304.5.1, R304.2.2, R304.5.3**
