Access Compliance Report Public Rights-of-Way (Curb Ramps)

Main Street: OAKTON HUNT DR **Cross Street: WRAYHILL DR** Location: Intersection ID: 31202 W Ramp Type: PerpDiag Initial Pass/Fail: Fail **Overall Compliance: No** Severity Score: 33.75 **ADA ID: AC248B2B368D**

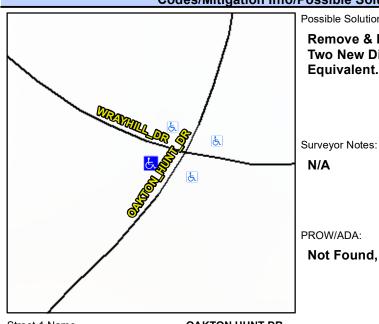
Not Found, R304.5.1, R304.5.3

Compli	ance Description	Data	Compli	ance Description	
N/A	Ramp Length (in)	48.0	Yes	Ramp Slope (%)	
No	Ramp Width (in)	47.0	No	Ramp XSlope (%)	
N/A	Flare Type LT	N/A	N/A	Flare Type RT	
N/A	Flare Slope LT (%)	N/A	N/A	Flare Slope RT (%)	
N/A	Flare Traversable LT?	N/A	N/A	Flare Traversable R	T?
N/A	Landing Length (in)	N/A	N/A	DWS Provided?	
N/A	Landing Width (in)	N/A	N/A	DWS Contrast?	
N/A	Landing Slope (%)	N/A	N/A	DWS Length (in)	
N/A	Landing X Slope (%)	N/A	N/A	DWS Full Width?	
N/A	Landing Curb? (Y/N)	N/A	N/A	DWS Offset (in)	
N/A	Shared Landing?	N/A			
N/A	Gutter Ponding?	N/A	N/A	Gutter Slope (%)	
N/A	Gutter Lip Ht (in)	N/A	N/A	Gutter X Slope (%)	
N/A	Painted X Walk1?	No	N/A	Painted X Walk2?	
	X Walk 1 Direction	To SE		X Walk 2 Direction	
N/A	X Walk 1 Width (in)	N/A	N/A	X Walk 2 Width (in)	
	X Walk 1 Slope (%)	3.2		X Walk 2 Slope (%)	
	X Walk 1 X Slope (%)	4.5		X Walk 2 X Slope (9	%)
N/A	Ramp inside XWalk1?	N/A	N/A	Ramp inside XWalk	2?

Road Slope (%)	9.6	N/A	Clear Space?	
	Road X Slope (%)	6.6	N/A	Clear Space to XWa	alk (in)
N/A	Any Obstructions?	N/A	N/A	Storm Grate/Utility I	Hazard?
	Obstruction Type			Storm Grate/Utility	Гуре

Possible Solutions: Remove & Replace Curb Ramp With Two New Directional Ramps or Equivalent.
