# Access Compliance Report

## Public Rights-of-Way

### (Curb Ramps)

Intersection ID: 43691	Main Street: PORTSTEWART_LN	Cross Street: TEW_CT	Location: NE
ADA ID: AC25C0EC14F4	Ramp Type: BlendTrans1	Initial Pass/Fail: Fail	Overall Compliance: No
Severity Score: 36.25			
Codes/Mitigation Info/Possible Solution		Field Measurements/Component Compliance

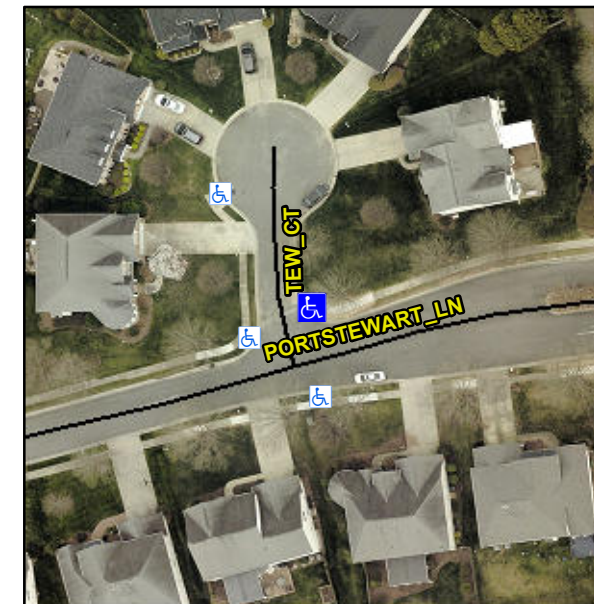
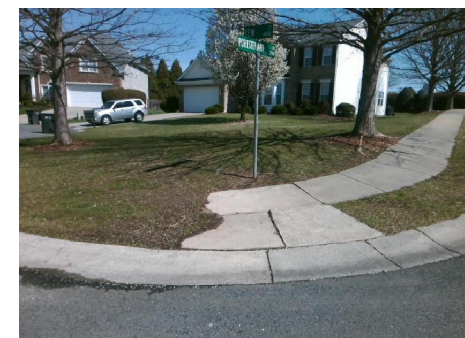
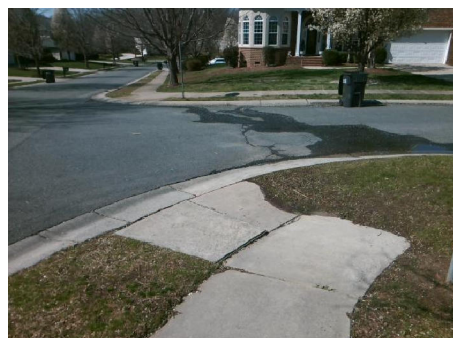
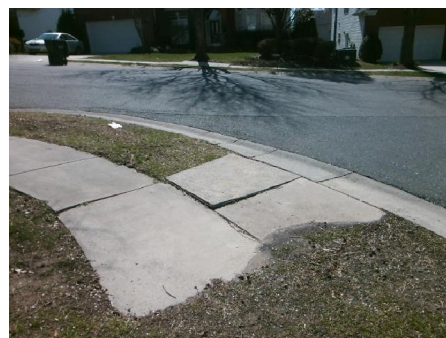
**Not Found, R304.5.1, R304.5.3, R302.7**

Compliance	Description	Data	Compliance	Description	Data
N/A	Ramp Length (in)	51.5	Yes	BlendTrans Slope (%)	3.2
No	Ramp Width (in)	41.0	No	BlendTrans XSlope (%)	6.9
N/A	Flare Type LT	N/A	N/A	Flare Type RT	N/A
N/A	Flare Slope LT (%)	N/A	N/A	Flare Slope RT (%)	N/A
N/A	Flare Traversable LT?	N/A	N/A	Flare Traversable RT?	N/A
N/A	Landing Length (in)	N/A	N/A	DWS Provided?	N/A
N/A	Landing Width (in)	N/A	N/A	DWS Contrast?	N/A
N/A	Landing Slope (%)	N/A	N/A	DWS Length (in)	N/A
N/A	Landing X Slope (%)	N/A	N/A	DWS Full Width?	N/A
N/A	Landing Curb? (Y/N)	N/A	N/A	DWS Offset (in)	N/A
N/A	Shared Landing?	N/A			
N/A	Gutter Ponding?	N/A	N/A	Gutter Slope (%)	N/A
N/A	Gutter Lip Ht (in)	N/A	N/A	Gutter X Slope (%)	N/A
N/A	Painted X Walk1?	No	N/A	Painted X Walk2?	No
	X Walk 1 Direction	To W		X Walk 2 Direction	To S
	X Walk 1 Width (in)	N/A		X Walk 2 Width (in)	N/A
	X Walk 1 Slope (%)	3.5		X Walk 2 Slope (%)	4.0
	X Walk 1 X Slope (%)	5.1		X Walk 2 X Slope (%)	5.2

N/A	Ramp inside XWalk1?	N/A	N/A	Ramp inside XWalk2?	N/A
	Road Slope (%)	6.4		Clear Space?	N/A
	Road X Slope (%)	2.0	N/A	Clear Space to XWalk (in)	N/A
N/A	Any Obstructions?	N/A	N/A	Storm Grate/Utility Hazard?	N/A
	Obstruction Type			Storm Grate/Utility Type	
		N/A			N/A
		No		Surface Condition? (G/P)	Poor
		No		Curb Slope (%)	10.5

**Remove & Replace Curb Ramp With Two New Directional Ramps or Equivalent.**
