# Access Compliance Report

## Public Rights-of-Way

### (Curb Ramps)

Intersection ID: 15340	Main Street: CHARLOTTE_DR	Cross Street: LATTIMORE_ST	Location:	E
ADA ID: AC2CF553D7AF	Ramp Type: Perp	Initial Pass/Fail: Fail	Overall Compliance: No	Severity Score: 12.5
Codes/Mitigation Info/Possible Solution		Field Measurements/Component Compliance

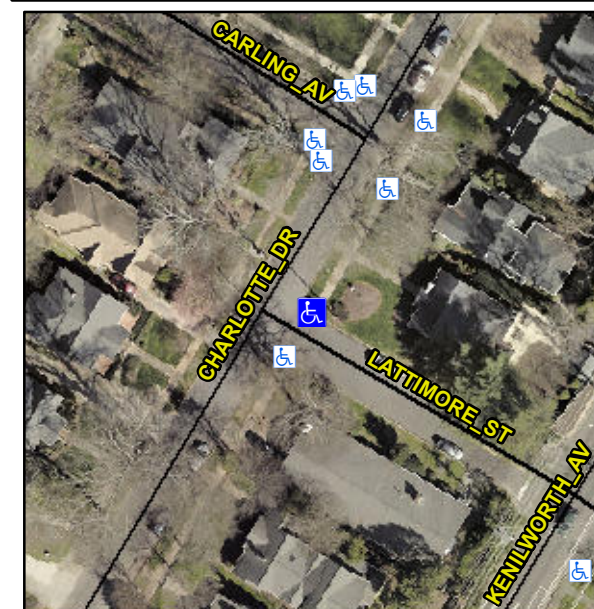
**Not Found, R304.2.2**

Compliance	Description	Data	Compliance	Description	Data
N/A	Ramp Length (in)	132.0	No	Ramp Slope (%)	11.8
Yes	Ramp Width (in)	48.0	Yes	Ramp XSlope (%)	1.1
N/A	Flare Type LT	N/A	N/A	Flare Type RT	N/A
N/A	Flare Slope LT (%)	N/A	N/A	Flare Slope RT (%)	N/A
N/A	Flare Traversable LT?	N/A	N/A	Flare Traversable RT?	N/A
N/A	Landing Length (in)	N/A	N/A	DWS Provided?	N/A
N/A	Landing Width (in)	N/A	N/A	DWS Contrast?	N/A
N/A	Landing Slope (%)	N/A	N/A	DWS Length (in)	N/A
N/A	Landing X Slope (%)	N/A	N/A	DWS Full Width?	N/A
N/A	Landing Curb? (Y/N)	N/A	N/A	DWS Offset (in)	N/A
N/A	Shared Landing?	N/A			
N/A	Gutter Ponding?	N/A	N/A	Gutter Slope (%)	N/A
N/A	Gutter Lip Ht (in)	1.0	N/A	Gutter X Slope (%)	N/A
N/A	Painted X Walk1?	No	N/A	Painted X Walk2?	N/A
	X Walk 1 Direction	To SW		X Walk 2 Direction	N/A
N/A	X Walk 1 Width (in)	N/A	N/A	X Walk 2 Width (in)	N/A
	X Walk 1 Slope (%)	1.1		X Walk 2 Slope (%)	N/A
	X Walk 1 X Slope (%)	4.2		X Walk 2 X Slope (%)	N/A

**Remove & Replace Entire Ramp.**
