# Access Compliance Report Public Rights-of-Way (Curb Ramps)

Intersection ID: 15049	Main Street: DILWORTH RD WEST	Cross Street: MAGNOLIA AV	Location: NW
ADA ID: AC2E12D2A4EA	Ramp Type: Perp	Initial Pass/Fail: Fail	Overall Compliance: No Severity Score: 1.25

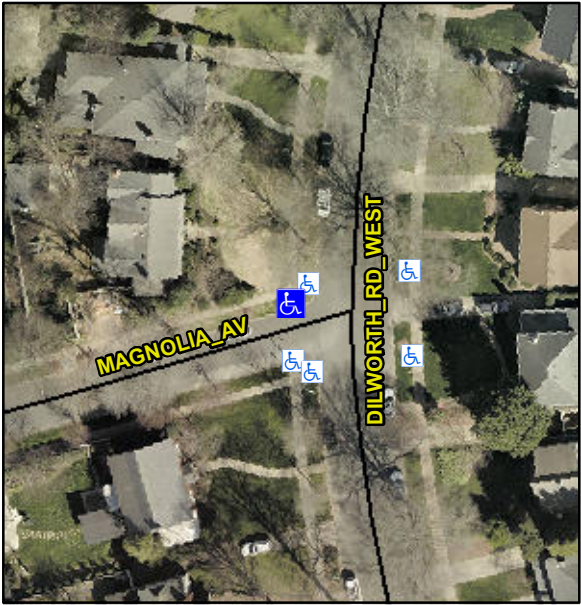
PROW/ADA:  
**Not Found, R304.5.3**

Compliance	Description	Data	Compliance	Description	Data
N/A	Ramp Length (in)	78.0	Yes	Ramp Slope (%)	7.7
Yes	Ramp Width (in)	48.0	No	Ramp XSlope (%)	4.5
N/A	Flare Type LT	N/A	N/A	Flare Type RT	N/A
N/A	Flare Slope LT (%)	N/A	N/A	Flare Slope RT (%)	N/A
N/A	Flare Traversable LT?	N/A	N/A	Flare Traversable RT?	N/A
N/A	Landing Length (in)	N/A	N/A	DWS Provided?	N/A
N/A	Landing Width (in)	N/A	N/A	DWS Contrast?	N/A
N/A	Landing Slope (%)	N/A	N/A	DWS Length (in)	N/A
N/A	Landing X Slope (%)	N/A	N/A	DWS Full Width?	N/A
N/A	Landing Curb? (Y/N)	N/A	N/A	DWS Offset (in)	N/A
N/A	Shared Landing?	N/A			
N/A	Gutter Ponding?	N/A	N/A	Gutter Slope (%)	N/A
N/A	Gutter Lip Ht (in)	N/A	N/A	Gutter X Slope (%)	N/A
N/A	Painted X Walk1?	No	N/A	Painted X Walk2?	N/A
	X Walk 1 Direction	To SW		X Walk 2 Direction	N/A
N/A	X Walk 1 Width (in)	N/A	N/A	X Walk 2 Width (in)	N/A
	X Walk 1 Slope (%)	2.9		X Walk 2 Slope (%)	N/A
	X Walk 1 X Slope (%)	3.1		X Walk 2 X Slope (%)	N/A

Possible Solutions:  
**Remove & Replace Entire Ramp.**

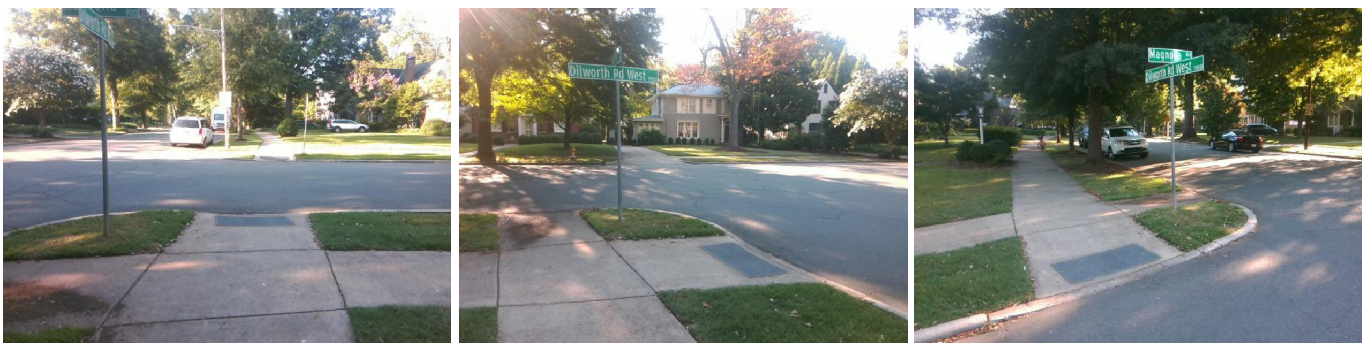
N/A	Ramp inside XWalk1?	N/A	N/A	Ramp inside XWalk2?	N/A
	Road Slope (%)	N/A	N/A	Clear Space?	N/A
	Road X Slope (%)	N/A	N/A	Clear Space to XWalk (in)	N/A
N/A	Any Obstructions?	N/A	N/A	Storm Grate/Utility Hazard?	N/A
	Obstruction Type			Storm Grate/Utility Type	
			N/A		N/A
			Yes	Surface Condition? (G/P)	Good
