Access Compliance Report

Public Rights-of-Way

(Curb Ramps)

Intersection ID: 9807	Main Street: TINNIN_AV	Cross Street: DOUBLE_OAKS_RD	Location: SW
ADA ID: AC3665A18E91	Ramp Type: PerpDiag	Initial Pass/Fail: Fail	Overall Compliance: No
			Severity Score: 21.25

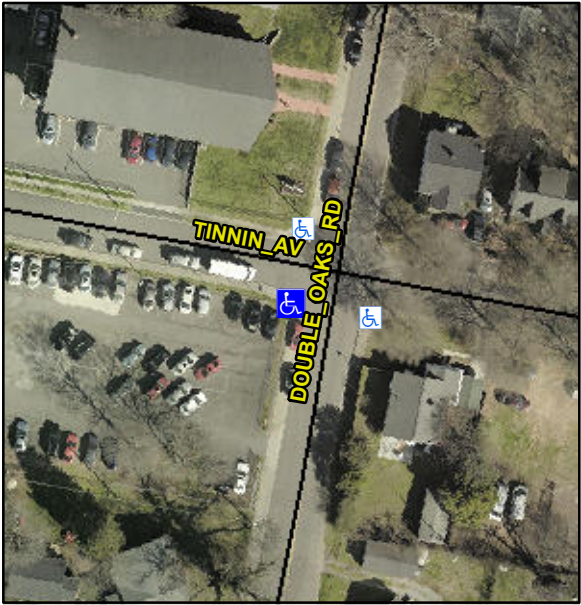
Compliance	Description	Data	Compliance	Description	Data
N/A	Ramp Length (in)	65.5	No	Ramp Slope (%)	10.3
No	Ramp Width (in)	42.5	Yes	Ramp XSlope (%)	1.4
N/A	Flare Type LT	N/A	N/A	Flare Type RT	N/A
N/A	Flare Slope LT (%)	N/A	N/A	Flare Slope RT (%)	N/A
N/A	Flare Traversable LT?	N/A	N/A	Flare Traversable RT?	N/A
N/A	Landing Length (in)	N/A	N/A	DWS Provided?	N/A
N/A	Landing Width (in)	N/A	N/A	DWS Contrast?	N/A
N/A	Landing Slope (%)	N/A	N/A	DWS Length (in)	N/A
N/A	Landing X Slope (%)	N/A	N/A	DWS Full Width?	N/A
N/A	Landing Curb? (Y/N)	N/A	N/A	DWS Offset (in)	N/A
N/A	Shared Landing?	N/A			
N/A	Gutter Ponding?	N/A	N/A	Gutter Slope (%)	N/A
N/A	Gutter Lip Ht (in)	N/A	N/A	Gutter X Slope (%)	N/A
N/A	Painted X Walk1?	No	N/A	Painted X Walk2?	No
	X Walk 1 Direction	To SE		X Walk 2 Direction	To N
N/A	X Walk 1 Width (in)	N/A	N/A	X Walk 2 Width (in)	N/A
	X Walk 1 Slope (%)	6.6		X Walk 2 Slope (%)	3.3
	X Walk 1 X Slope (%)	2.7		X Walk 2 X Slope (%)	4.4

N/A	Ramp inside XWalk1?	N/A	N/A	Ramp inside XWalk2?	N/A
	Road Slope (%)	1.1	N/A	Clear Space?	N/A
	Road X Slope (%)	6.2	N/A	Clear Space to XWalk (in)	N/A
N/A	Any Obstructions?	N/A	N/A	Storm Grate/Utility Hazard?	N/A
	Obstruction Type			Storm Grate/Utility Type	
		N/A			N/A
			Yes	Surface Condition? (G/P)	Good

Possible Solutions:				
	Remove & Replace Curb Ramp With Two New Directional Ramps or Equivalent.				
	Surveyor Notes:				
	N/A				
	PROW/ADA:				
	R304.5.1, R304.2.2				
Street 1 Name	DOUBLE OAKS RD				
Stop Condition-Street 2	None				
Street 2 Name	TINNIN AV				
Stop Condition-Street 1	StopSign				
Total Cost:		\$	3200.00
