Access Compliance Report

Public Rights-of-Way

(Curb Ramps)

Intersection ID: 12413	Main Street: N_BREVARD_ST	Cross Street: E_6TH_ST	Location:	N
ADA ID: AC3A8868FE6C	Ramp Type: Perp	Initial Pass/Fail: Fail	Overall Compliance: No	Severity Score: 12.5
Codes/Mitigation Info/Possible Solution		Field Measurements/Component Compliance

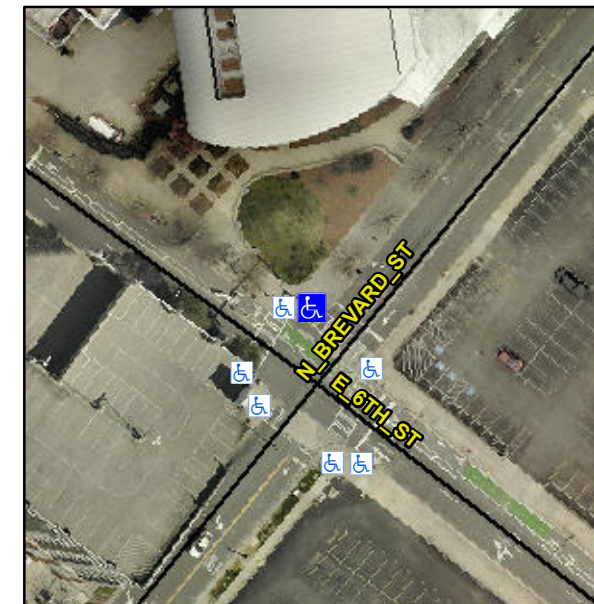
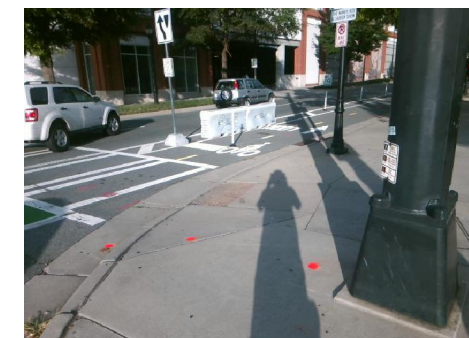
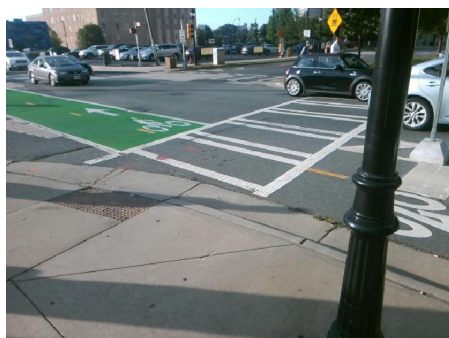
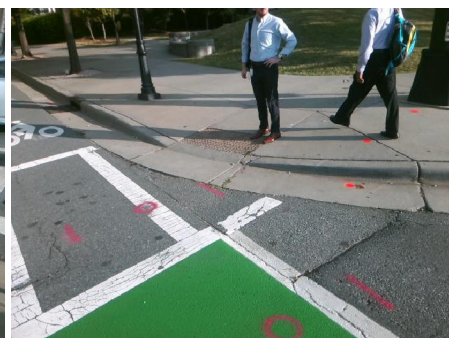
Not Found, R304.2.2

Compliance	Description	Data	Compliance	Description	Data
N/A	Ramp Length (in)	72.0	No	Ramp Slope (%)	9.8
Yes	Ramp Width (in)	48.0	Yes	Ramp XSlope (%)	0.7
N/A	Flare Type LT	N/A	N/A	Flare Type RT	N/A
N/A	Flare Slope LT (%)	N/A	N/A	Flare Slope RT (%)	N/A
N/A	Flare Traversable LT?	N/A	N/A	Flare Traversable RT?	N/A
N/A	Landing Length (in)	N/A	N/A	DWS Provided?	N/A
N/A	Landing Width (in)	N/A	N/A	DWS Contrast?	N/A
N/A	Landing Slope (%)	N/A	N/A	DWS Length (in)	N/A
N/A	Landing X Slope (%)	N/A	N/A	DWS Full Width?	N/A
N/A	Landing Curb? (Y/N)	N/A	N/A	DWS Offset (in)	N/A
N/A	Shared Landing?	N/A			
N/A	Gutter Ponding?	N/A	N/A	Gutter Slope (%)	N/A
N/A	Gutter Lip Ht (in)	N/A	N/A	Gutter X Slope (%)	N/A
N/A	Painted X Walk1?	Yes	N/A	Painted X Walk2?	N/A
	X Walk 1 Direction	To SE		X Walk 2 Direction	N/A
N/A	X Walk 1 Width (in)	112.0	N/A	X Walk 2 Width (in)	N/A
	X Walk 1 Slope (%)	0.6		X Walk 2 Slope (%)	N/A
	X Walk 1 X Slope (%)	0.2		X Walk 2 X Slope (%)	N/A

Remove & Replace Entire Ramp.
