Intersection ID: 9069	Main Street: HEIL_PL	Cross Street: MULBERRY_AV	Location:	NW
ADA ID: AC46C19CAEFC	Ramp Type: PerpDiag	Initial Pass/Fail: Fail	Overall Compliance: No	Severity Score: 37.5

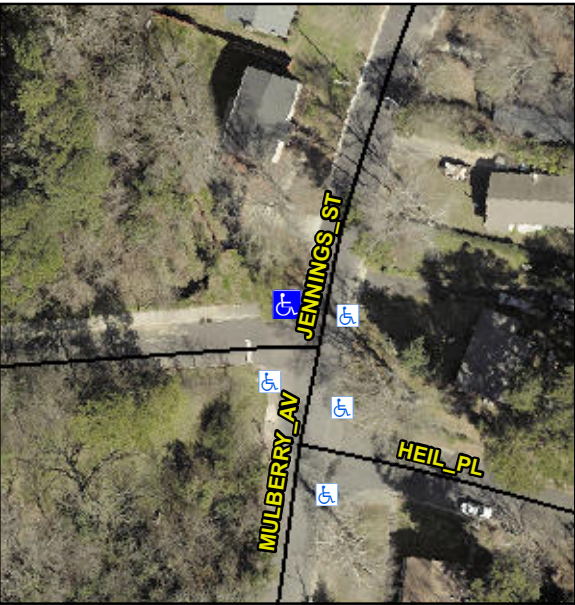
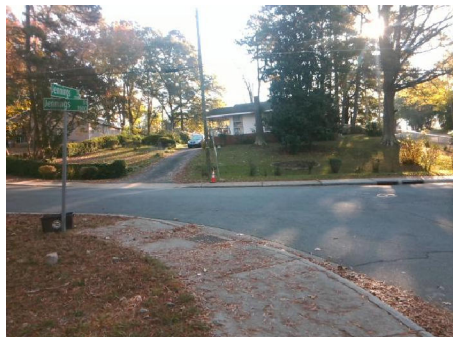
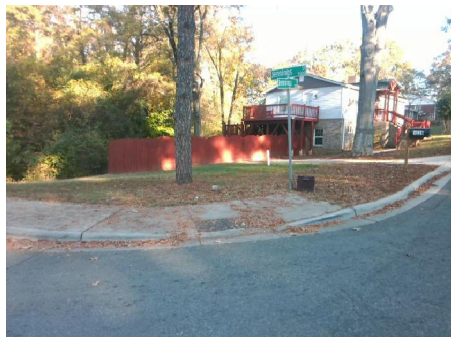
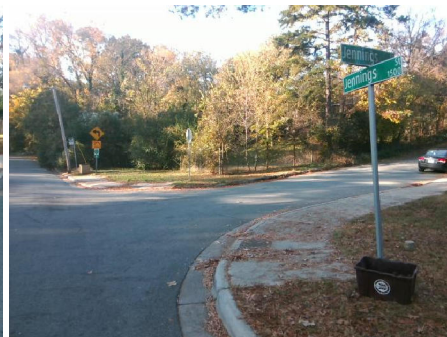
Possible Solutions:		Compliance	Description	Data	Compliance	Description	Data
	Remove & Replace Curb Ramp With Two New Directional Ramps or Equivalent.		N/A	Ramp Length (in)	71.5	No	Ramp Slope (%)	9.1
			Yes	Ramp Width (in)	48.0	No	Ramp XSlope (%)	7.0
			N/A	Flare Type LT	N/A	N/A	Flare Type RT	N/A
			N/A	Flare Slope LT (%)	N/A	N/A	Flare Slope RT (%)	N/A
			N/A	Flare Traversable LT?	N/A	N/A	Flare Traversable RT?	N/A
			N/A	Landing Length (in)	N/A	N/A	DWS Provided?	N/A
			N/A	Landing Width (in)	N/A	N/A	DWS Contrast?	N/A
			N/A	Landing Slope (%)	N/A	N/A	DWS Length (in)	N/A
			N/A	Landing X Slope (%)	N/A	N/A	DWS Full Width?	N/A
<p>Surveyor Notes:</p> <p>N/A</p>			N/A	Landing Curb? (Y/N)	N/A	N/A	DWS Offset (in)	N/A
			N/A	Shared Landing?	N/A			
			N/A	Gutter Ponding?	N/A	N/A	Gutter Slope (%)	N/A
			N/A	Gutter Lip Ht (in)	N/A	N/A	Gutter X Slope (%)	N/A

N/A	Painted X Walk1?	No	N/A	Painted X Walk2?	No
				X Walk 1 Direction	To S		X Walk 2 Direction	To E
			N/A	X Walk 1 Width (in)	N/A	N/A	X Walk 2 Width (in)	N/A
				X Walk 1 Slope (%)	4.7		X Walk 2 Slope (%)	4.2
				X Walk 1 X Slope (%)	2.5		X Walk 2 X Slope (%)	5.3
			N/A	Ramp inside XWalk1?	N/A	N/A	Ramp inside XWalk2?	N/A
<p>PROW/ADA:</p> <p>Not Found, R304.2.2, R304.5.3</p>				Road Slope (%)	6.3	N/A	Clear Space?	N/A
				Road X Slope (%)	1.0	N/A	Clear Space to XWalk (in)	N/A
			N/A	Any Obstructions?	N/A	N/A	Storm Grate/Utility Hazard?	N/A
				Obstruction Type			Storm Grate/Utility Type	
					N/A			N/A
						Yes	Surface Condition? (G/P)	Good
Street 1 Name	JENNINGS ST							
Stop Condition-Street 2	StopSign							
Street 2 Name	JENNINGS ST							
Stop Condition-Street 1	None							
Total Cost:	\$	3200.00
