Access Compliance Report

Public Rights-of-Way

(Curb Ramps)

Intersection ID: 47099	Main Street: GALLERIA_BV	Cross Street: N/A	Location: S
ADA ID: AC65019D66B3	Ramp Type: Perp	Initial Pass/Fail: Fail	Overall Compliance: No
Severity Score: 12.5			
Codes/Mitigation Info/Possible Solution		Field Measurements/Component Compliance

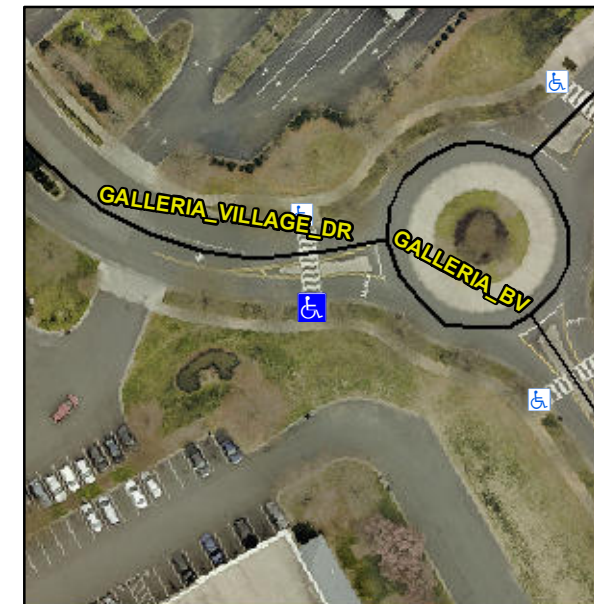
Not Found, R304.2.2

Compliance	Description	Data	Compliance	Description	Data
N/A	Ramp Length (in)	95.0	No	Ramp Slope (%)	8.7
Yes	Ramp Width (in)	49.5	Yes	Ramp XSlope (%)	2.0
N/A	Flare Type LT	N/A	N/A	Flare Type RT	N/A
N/A	Flare Slope LT (%)	N/A	N/A	Flare Slope RT (%)	N/A
N/A	Flare Traversable LT?	N/A	N/A	Flare Traversable RT?	N/A
N/A	Landing Length (in)	N/A	N/A	DWS Provided?	N/A
N/A	Landing Width (in)	N/A	N/A	DWS Contrast?	N/A
N/A	Landing Slope (%)	N/A	N/A	DWS Length (in)	N/A
N/A	Landing X Slope (%)	N/A	N/A	DWS Full Width?	N/A
N/A	Landing Curb? (Y/N)	N/A	N/A	DWS Offset (in)	N/A
N/A	Shared Landing?	N/A			
N/A	Gutter Ponding?	N/A	N/A	Gutter Slope (%)	N/A
N/A	Gutter Lip Ht (in)	N/A	N/A	Gutter X Slope (%)	N/A
N/A	Painted X Walk1?	Yes	N/A	Painted X Walk2?	N/A
	X Walk 1 Direction	To N		X Walk 2 Direction	N/A
N/A	X Walk 1 Width (in)	99.0	N/A	X Walk 2 Width (in)	N/A
	X Walk 1 Slope (%)	0.5		X Walk 2 Slope (%)	N/A
	X Walk 1 X Slope (%)	0.2		X Walk 2 X Slope (%)	N/A

N/A	Ramp inside XWalk1?	Yes	N/A	Ramp inside XWalk2?	N/A
	Road Slope (%)	N/A	N/A	Clear Space?	N/A
	Road X Slope (%)	N/A	N/A	Clear Space to XWalk (in)	N/A
N/A	Any Obstructions?	N/A	N/A	Storm Grate/Utility Hazard?	N/A
	Obstruction Type			Storm Grate/Utility Type	
		N/A			N/A
		Yes		Surface Condition? (G/P)	Good

Possible Solutions:

Remove & Replace Entire Ramp.
