Access Compliance Report

Public Rights-of-Way

(Curb Ramps)

| Intersection ID: 20140 | Main Street: DEERMONT_CT | Cross Street: PINEBURR_RD | Location: E |

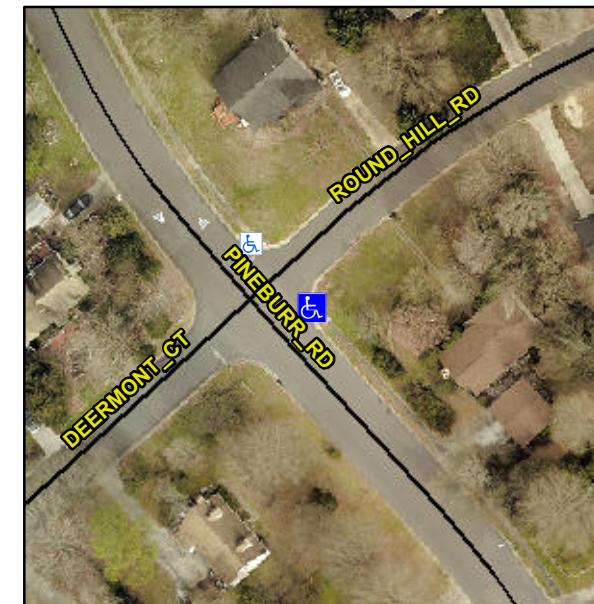
| ADA ID: AC6793BC8827 | Ramp Type: PerpDiag | Initial Pass/Fail: Fail | Overall Compliance: No |

Not Found, R304.5.1, R304.2.2, R304.5.3

| Compliance | Description | Data | Compliance | Description | Data |
|---|---|---|---|---|---|
| N/A | Ramp Length (in) | 72.0 | No | Ramp Slope (%) | 13.0 |
| No | Ramp Width (in) | 47.0 | No | Ramp XSlope (%) | 9.0 |

Remove & Replace Curb Ramp With Two New Directional Ramps or Equivalent.
