Access Compliance Report

Public Rights-of-Way

(Curb Ramps)

Intersection ID: 50998	Main Street: S_TRYON_ST	Cross Street: STEELECROFT_PY	Location: SE
ADA ID: AC6D25B02582	Ramp Type: Perp	Initial Pass/Fail: Fail	Overall Compliance: No
Severity Score: 33.75			
Codes/Mitigation Info/Possible Solution		Field Measurements/Component Compliance

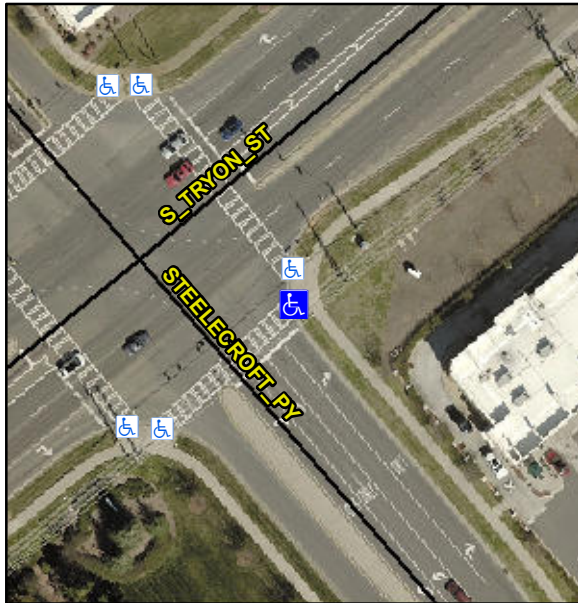
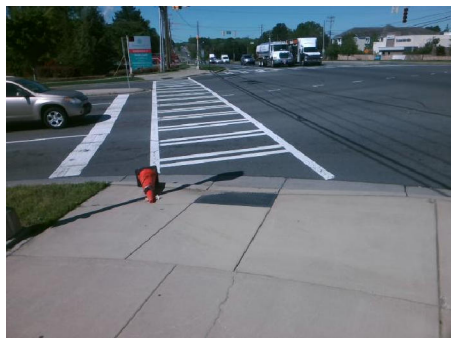
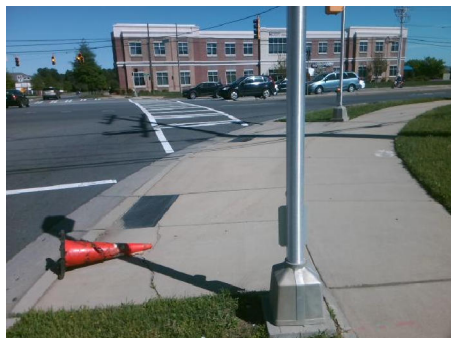
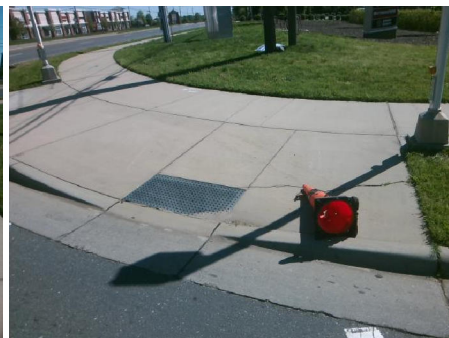
R304.5.1, R304.5.3

Compliance	Description	Data	Compliance	Description	Data
N/A	Ramp Length (in)	95.0	Yes	Ramp Slope (%)	7.5
No	Ramp Width (in)	47.0	No	Ramp XSlope (%)	8.0
N/A	Flare Type LT	N/A	N/A	Flare Type RT	N/A
N/A	Flare Slope LT (%)	N/A	N/A	Flare Slope RT (%)	N/A
N/A	Flare Traversable LT?	N/A	N/A	Flare Traversable RT?	N/A
N/A	Landing Length (in)	N/A	N/A	DWS Provided?	N/A
N/A	Landing Width (in)	N/A	N/A	DWS Contrast?	N/A
N/A	Landing Slope (%)	N/A	N/A	DWS Length (in)	N/A
N/A	Landing X Slope (%)	N/A	N/A	DWS Full Width?	N/A
N/A	Landing Curb? (Y/N)	N/A	N/A	DWS Offset (in)	N/A
N/A	Shared Landing?	N/A			
N/A	Gutter Ponding?	N/A	N/A	Gutter Slope (%)	N/A
N/A	Gutter Lip Ht (in)	N/A	N/A	Gutter X Slope (%)	N/A
N/A	Painted X Walk1?	Yes	N/A	Painted X Walk2?	N/A
	X Walk 1 Direction	To SW		X Walk 2 Direction	N/A
N/A	X Walk 1 Width (in)	112.0	N/A	X Walk 2 Width (in)	N/A
	X Walk 1 Slope (%)	1.3		X Walk 2 Slope (%)	N/A
	X Walk 1 X Slope (%)	5.6		X Walk 2 X Slope (%)	N/A

N/A	Ramp inside XWalk1?	Yes	N/A	Ramp inside XWalk2?	N/A
	Road Slope (%)	N/A	N/A	Clear Space?	N/A
	Road X Slope (%)	N/A	N/A	Clear Space to XWalk (in)	N/A
N/A	Any Obstructions?	N/A	N/A	Storm Grate/Utility Hazard?	N/A
	Obstruction Type			Storm Grate/Utility Type	
		N/A			N/A
		Yes		Surface Condition? (G/P)	Good

Remove & Replace Entire Ramp.
