# Access Compliance Report

## Public Rights-of-Way

### (Curb Ramps)

Intersection ID: N/A	Main Street: ROMARE_BEARDEN_DR	Cross Street: FARMER_ST	Location: NE
ADA ID: AC74350C39D9	Ramp Type: PerpDiag	Initial Pass/Fail: Fail	Overall Compliance: No
Severity Score: 21.25			
Codes/Mitigation Info/Possible Solution		Field Measurements/Component Compliance

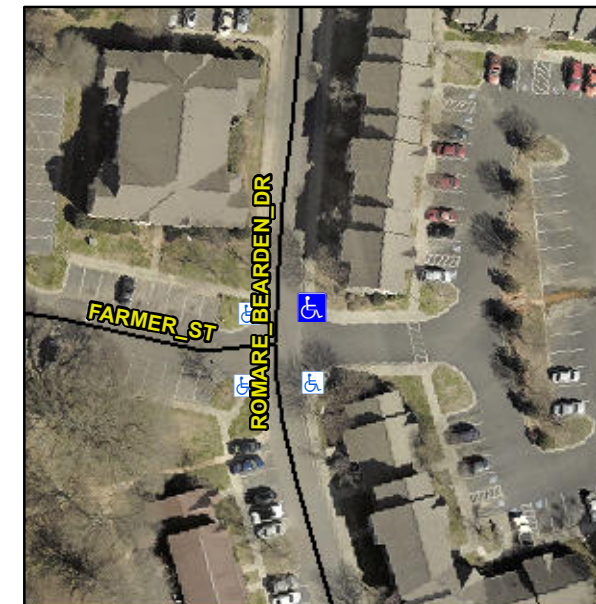
**Not Found, R304.5.1, R304.5.3**

Compliance	Description	Data	Compliance	Description	Data
N/A	Ramp Length (in)	61.0	Yes	Ramp Slope (%)	5.4
No	Ramp Width (in)	37.0	No	Ramp XSlope (%)	6.2
N/A	Flare Type LT	N/A	N/A	Flare Type RT	N/A
N/A	Flare Slope LT (%)	N/A	N/A	Flare Slope RT (%)	N/A
N/A	Flare Traversable LT?	N/A	N/A	Flare Traversable RT?	N/A
N/A	Landing Length (in)	N/A	N/A	DWS Provided?	N/A
N/A	Landing Width (in)	N/A	N/A	DWS Contrast?	N/A
N/A	Landing Slope (%)	N/A	N/A	DWS Length (in)	N/A
N/A	Landing X Slope (%)	N/A	N/A	DWS Full Width?	N/A
N/A	Landing Curb? (Y/N)	N/A	N/A	DWS Offset (in)	N/A
N/A	Shared Landing?	N/A			
N/A	Gutter Ponding?	N/A	N/A	Gutter Slope (%)	N/A
N/A	Gutter Lip Ht (in)	N/A	N/A	Gutter X Slope (%)	N/A
N/A	Painted X Walk1?	No	N/A	Painted X Walk2?	No
	X Walk 1 Direction	To W		X Walk 2 Direction	To S
N/A	X Walk 1 Width (in)	N/A	N/A	X Walk 2 Width (in)	N/A
	X Walk 1 Slope (%)	0.6		X Walk 2 Slope (%)	4.4
	X Walk 1 X Slope (%)	4.6		X Walk 2 X Slope (%)	4.1

N/A	Ramp inside XWalk1?	N/A	N/A	Ramp inside XWalk2?	N/A
	Road Slope (%)	5.3	N/A	Clear Space?	N/A
	Road X Slope (%)	1.0	N/A	Clear Space to XWalk (in)	N/A
N/A	Any Obstructions?	N/A	N/A	Storm Grate/Utility Hazard?	N/A
	Obstruction Type			Storm Grate/Utility Type	
		N/A			N/A
		Yes		Surface Condition? (G/P)	Good

**Remove & Replace Curb Ramp With Two New Directional Ramps or Equivalent.**

Total Cost: \$ 3200.00
