Access Compliance Report

Public Rights-of-Way

(Curb Ramps)

Intersection ID: N/A	Main Street: FAIRWOOD_AV	Cross Street: GRUFFITH_ST	Location: N
ADA ID: AC7806D352B9	Ramp Type: Perp	Initial Pass/Fail: Pass	Overall Compliance: No
Severity Score: 0.25			
Codes/Mitigation Info/Possible Solution		Field Measurements/Component Compliance

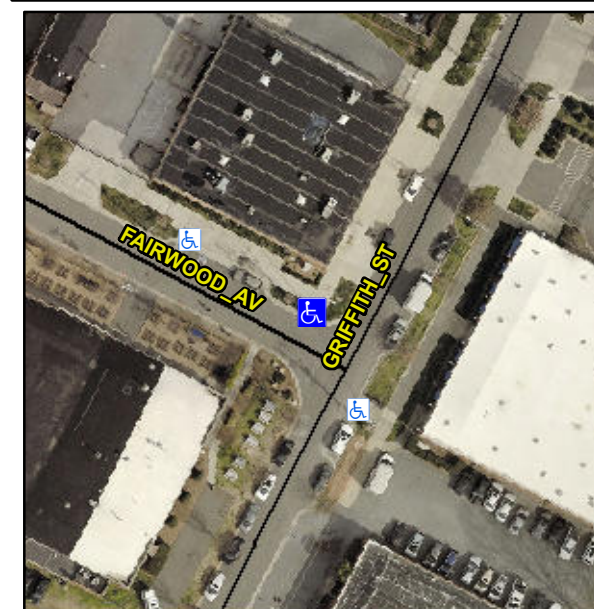
Not Found, R304.5.3

Compliance	Description	Data	Compliance	Description	Data
N/A	Ramp Length (in)	75.0	Yes	Ramp Slope (%)	5.4
Yes	Ramp Width (in)	86.0	No	Ramp XSlope (%)	2.4
Yes	Flare Type LT	Curbed_NoWalkSurface	Yes	Flare Type RT	N/A
Yes	Flare Slope LT (%)	N/A	N/A	Flare Slope RT (%)	N/A
N/A	Flare Traversable LT?	No	N/A	Flare Traversable RT?	No
Yes	Landing Length (in)	96.0	Yes	DWS Provided?	Yes
Yes	Landing Width (in)	85.0	Yes	DWS Contrast?	Yes
Yes	Landing Slope (%)	0.2	Yes	DWS Length (in)	25.5
Yes	Landing X Slope (%)	0.1	Yes	DWS Full Width?	Yes
N/A	Landing Curb? (Y/N)	No	Yes	DWS Offset (in)	2.0
N/A	Shared Landing?	No			
Yes	Gutter Ponding?	No	Yes	Gutter Slope (%)	1.8
Yes	Gutter Lip Ht (in)	0.0	No	Gutter X Slope (%)	2.8
N/A	Painted X Walk1?	No	N/A	Painted X Walk2?	N/A
	X Walk 1 Direction	To SW		X Walk 2 Direction	N/A
N/A	X Walk 1 Width (in)	N/A	N/A	X Walk 2 Width (in)	N/A
	X Walk 1 Slope (%)	1.8		X Walk 2 Slope (%)	N/A
	X Walk 1 X Slope (%)	2.0		X Walk 2 X Slope (%)	N/A

N/A	Ramp inside XWalk1?	N/A	N/A	Ramp inside XWalk2?	N/A
	Road Slope (%)	N/A	N/A	Clear Space?	Yes
	Road X Slope (%)	N/A	N/A	Clear Space to XWalk (in)	N/A
Yes	Any Obstructions?	No	Yes	Storm Grate/Utility Hazard?	No
	Obstruction Type			Storm Grate/Utility Type	
		N/A			N/A
			Yes	Surface Condition? (G/P)	Good

Remove & Replace Entire Ramp.
Remove & Replace Gutter.
