Access Compliance Report

Public Rights-of-Way

(Curb Ramps)

| Intersection ID: 11796 | Main Street: N_PINE_ST | Cross Street: W_6TH_ST | Location: S |

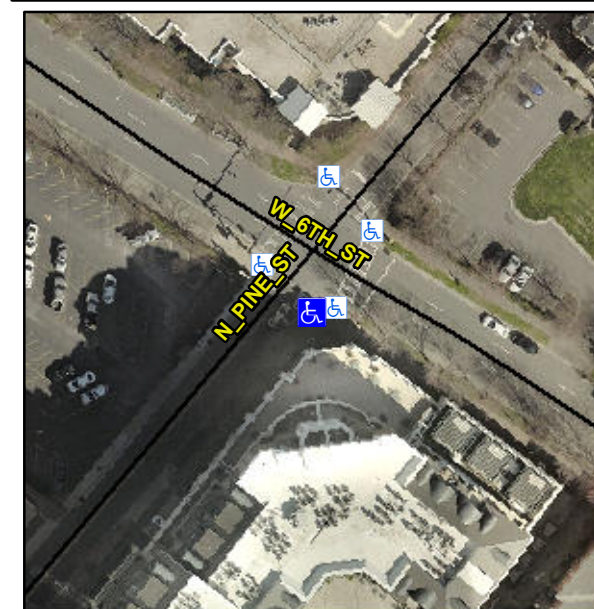
| ADA ID: AC7839D34A51 | Ramp Type: Perp | Initial Pass/Fail: Fail | Overall Compliance: No |
| Severity Score: 13.75 | | | |

Not Found, R304.2.2, R304.5.3

| Compliance | Description | Data | Compliance | Description | Data |
|---|---|---|---|---|---|
| N/A | Ramp Length (in) | 47.0 | No | Ramp Slope (%) | 8.8 |
| Yes | Ramp Width (in) | 59.0 | No | Ramp XSlope (%) | 2.6 |

Remove & Replace Entire Ramp.
