Access Compliance Report

Public Rights-of-Way

(Curb Ramps)

Intersection ID: 44317	Main Street: E_9TH_ST	Cross Street: N_CALDWELL_ST	Location: S
ADA ID: AC7E4BC4B5AD	Ramp Type: PerpDiag	Initial Pass/Fail: Fail	Overall Compliance: No
Severity Score: 13.75			
Codes/Mitigation Info/Possible Solution		Field Measurements/Component Compliance

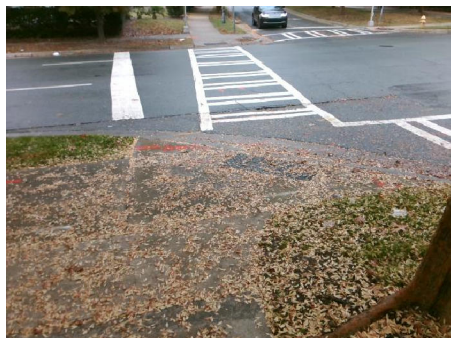
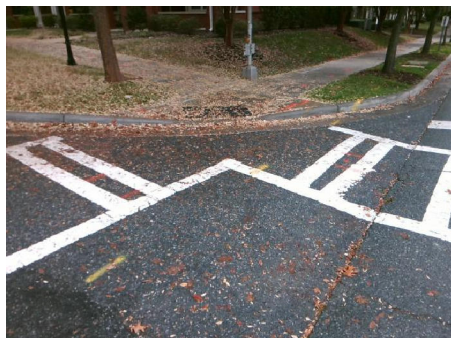
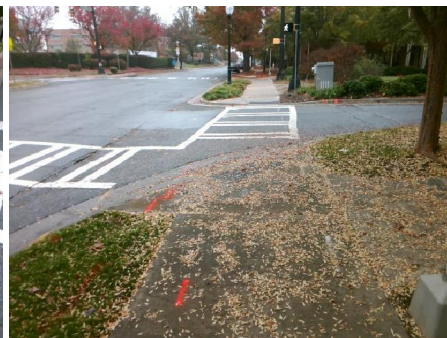
Compliance	Description	Data	Compliance	Description	Data
N/A	Ramp Length (in)	58.0	No	Ramp Slope (%)	9.0
Yes	Ramp Width (in)	50.0	No	Ramp XSlope (%)	4.7
N/A	Flare Type LT	N/A	N/A	Flare Type RT	N/A
N/A	Flare Slope LT (%)	N/A	N/A	Flare Slope RT (%)	N/A
N/A	Flare Traversable LT?	N/A	N/A	Flare Traversable RT?	N/A
N/A	Landing Length (in)	N/A	N/A	DWS Provided?	N/A
N/A	Landing Width (in)	N/A	N/A	DWS Contrast?	N/A
N/A	Landing Slope (%)	N/A	N/A	DWS Length (in)	N/A
N/A	Landing X Slope (%)	N/A	N/A	DWS Full Width?	N/A
N/A	Landing Curb? (Y/N)	N/A	N/A	DWS Offset (in)	N/A
N/A	Shared Landing?	N/A			
N/A	Gutter Ponding?	N/A	N/A	Gutter Slope (%)	N/A
N/A	Gutter Lip Ht (in)	N/A	N/A	Gutter X Slope (%)	N/A
N/A	Painted X Walk1?	Yes	N/A	Painted X Walk2?	Yes
	X Walk 1 Direction	To NE		X Walk 2 Direction	To NW
N/A	X Walk 1 Width (in)	101.0	N/A	X Walk 2 Width (in)	100.5
	X Walk 1 Slope (%)	3.3		X Walk 2 Slope (%)	3.6
	X Walk 1 X Slope (%)	3.9		X Walk 2 X Slope (%)	2.4

N/A	Ramp inside XWalk1?	Yes	N/A	Ramp inside XWalk2?	Yes
	Road Slope (%)	2.4	N/A	Clear Space?	N/A
	Road X Slope (%)	1.9	N/A	Clear Space to XWalk (in)	N/A
N/A	Any Obstructions?	N/A	N/A	Storm Grate/Utility Hazard?	N/A
	Obstruction Type			Storm Grate/Utility Type	
		N/A			N/A
		Yes		Surface Condition? (G/P)	Good

Possible Solutions:

Remove & Replace Curb Ramp With Two New Directional Ramps or Equivalent.
