Access Compliance Report

Public Rights-of-Way

(Curb Ramps)

Intersection ID: 45785	Main Street: SUGARBUSH_DR	Cross Street: LONG_HILL_DR	Location: S
ADA ID: AC8067E8056B	Ramp Type: PerpDiag	Initial Pass/Fail: Fail	Overall Compliance: No
Severity Score: 12.5			
Codes/Mitigation Info/Possible Solution		Field Measurements/Component Compliance

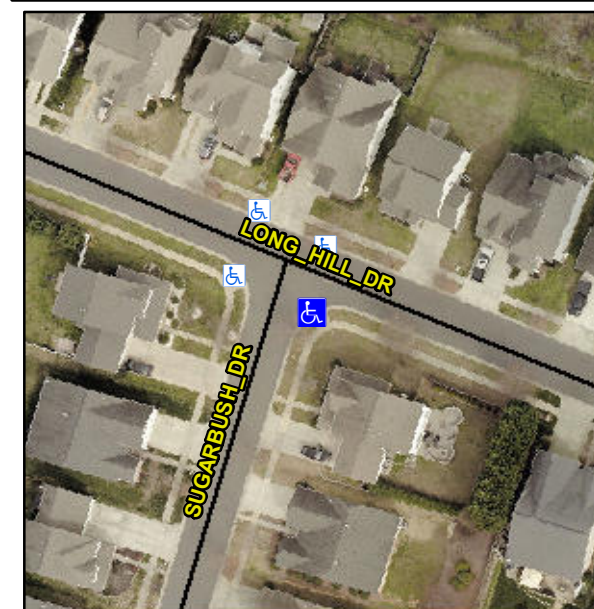
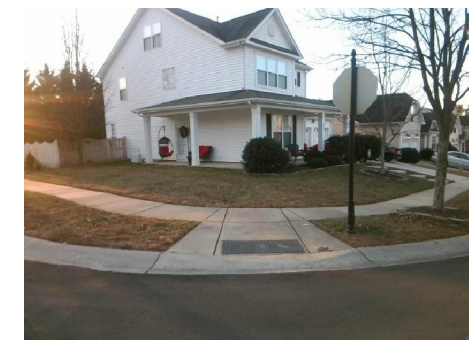
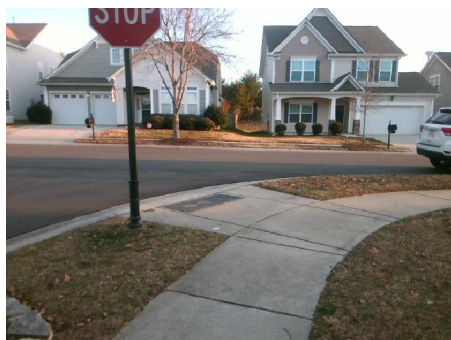
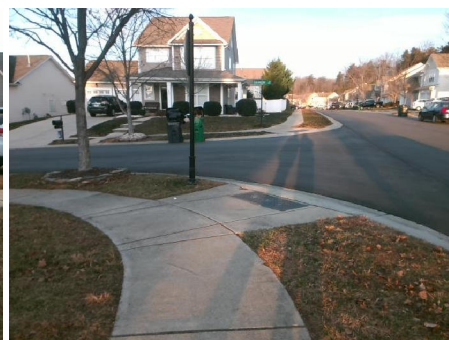
Not Found, R304.5.3

Compliance	Description	Data	Compliance	Description	Data
N/A	Ramp Length (in)	70.0	Yes	Ramp Slope (%)	5.1
Yes	Ramp Width (in)	48.0	No	Ramp XSlope (%)	5.3
N/A	Flare Type LT	N/A	N/A	Flare Type RT	N/A
N/A	Flare Slope LT (%)	N/A	N/A	Flare Slope RT (%)	N/A
N/A	Flare Traversable LT?	N/A	N/A	Flare Traversable RT?	N/A
N/A	Landing Length (in)	N/A	N/A	DWS Provided?	N/A
N/A	Landing Width (in)	N/A	N/A	DWS Contrast?	N/A
N/A	Landing Slope (%)	N/A	N/A	DWS Length (in)	N/A
N/A	Landing X Slope (%)	N/A	N/A	DWS Full Width?	N/A
N/A	Landing Curb? (Y/N)	N/A	N/A	DWS Offset (in)	N/A
N/A	Shared Landing?	N/A			
N/A	Gutter Ponding?	N/A	N/A	Gutter Slope (%)	N/A
N/A	Gutter Lip Ht (in)	N/A	N/A	Gutter X Slope (%)	N/A
N/A	Painted X Walk1?	No	N/A	Painted X Walk2?	No
	X Walk 1 Direction	To NE		X Walk 2 Direction	To NW
N/A	X Walk 1 Width (in)	N/A	N/A	X Walk 2 Width (in)	N/A
	X Walk 1 Slope (%)	3.5		X Walk 2 Slope (%)	3.4
	X Walk 1 X Slope (%)	0.6		X Walk 2 X Slope (%)	4.0

N/A	Ramp inside XWalk1?	N/A	N/A	Ramp inside XWalk2?	N/A
	Road Slope (%)	1.4	N/A	Clear Space?	N/A
	Road X Slope (%)	3.3	N/A	Clear Space to XWalk (in)	N/A
N/A	Any Obstructions?	N/A	N/A	Storm Grate/Utility Hazard?	N/A
	Obstruction Type			Storm Grate/Utility Type	
		N/A			N/A
		Yes		Surface Condition? (G/P)	Good

Remove & Replace Curb Ramp With Two New Directional Ramps or Equivalent.

Total Cost: \$ 3200.00
