Access Compliance Report

Public Rights-of-Way

(Curb Ramps)

| Intersection ID: 45542 | Main Street: HARRIER_RD | Cross Street: GOSHAWK_LN | Location: E |

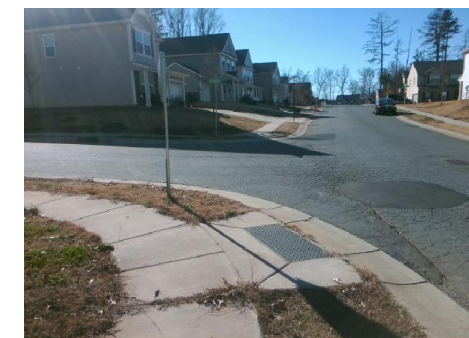
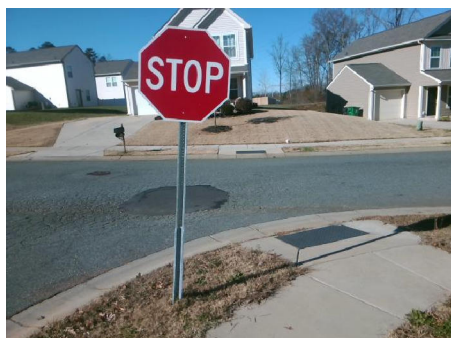
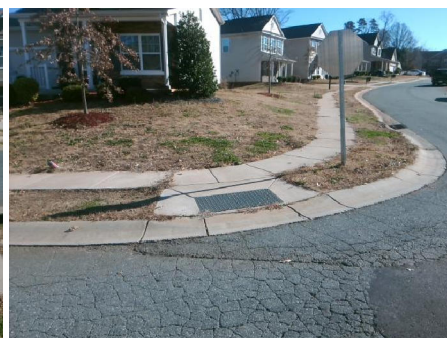
| ADA ID: AC80865B5915 | Ramp Type: PerpDiag | Initial Pass/Fail: Fail | Overall Compliance: No |
| Severity Score: 21.25 | | | |

Not Found, R304.5.1, R304.5.3

| Compliance | Description | Data | Compliance | Description | Data |
|---|---|---|---|---|---|
| N/A | Ramp Length (in) | 48.0 | Yes | Ramp Slope (%) | 7.6 |
| No | Ramp Width (in) | 47.5 | No | Ramp XSlope (%) | 5.1 |

Remove & Replace Curb Ramp With Two New Directional Ramps or Equivalent.

Total Cost: \$ 3200.00
