Access Compliance Report

Public Rights-of-Way

(Curb Ramps)

Intersection ID: 17009	Main Street: N_WENDOVER_RD	Cross Street: RANDOLPH_RD	Location: N
ADA ID: AC82C9AF33A1	Ramp Type: Perp	Initial Pass/Fail: Fail	Overall Compliance: No
Severity Score: 46.25			
Codes/Mitigation Info/Possible Solution		Field Measurements/Component Compliance

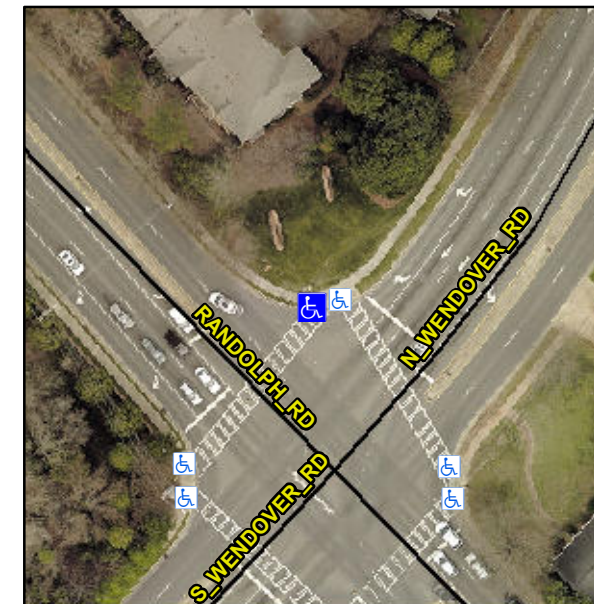
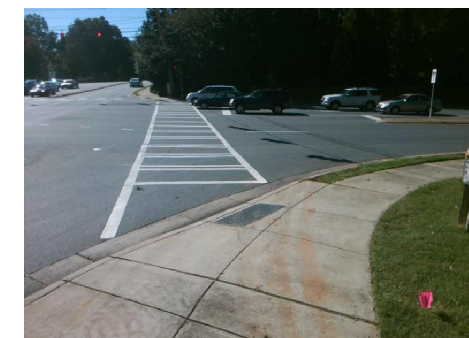
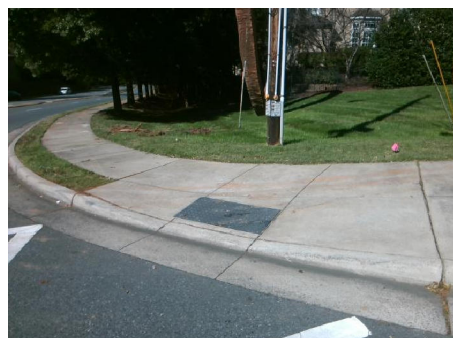
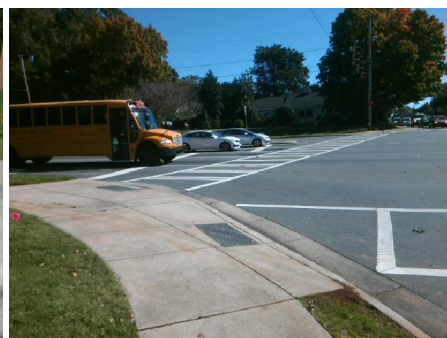
Not Found, R304.5.1, R304.2.2, R304.5.3

Compliance	Description	Data	Compliance	Description	Data
N/A	Ramp Length (in)	92.0	No	Ramp Slope (%)	9.5
No	Ramp Width (in)	46.0	No	Ramp XSlope (%)	7.8
N/A	Flare Type LT	N/A	N/A	Flare Type RT	N/A
N/A	Flare Slope LT (%)	N/A	N/A	Flare Slope RT (%)	N/A
N/A	Flare Traversable LT?	N/A	N/A	Flare Traversable RT?	N/A
N/A	Landing Length (in)	N/A	N/A	DWS Provided?	N/A
N/A	Landing Width (in)	N/A	N/A	DWS Contrast?	N/A
N/A	Landing Slope (%)	N/A	N/A	DWS Length (in)	N/A
N/A	Landing X Slope (%)	N/A	N/A	DWS Full Width?	N/A
N/A	Landing Curb? (Y/N)	N/A	N/A	DWS Offset (in)	N/A
N/A	Shared Landing?	N/A			
N/A	Gutter Ponding?	N/A	N/A	Gutter Slope (%)	N/A
N/A	Gutter Lip Ht (in)	N/A	N/A	Gutter X Slope (%)	N/A
N/A	Painted X Walk1?	Yes	N/A	Painted X Walk2?	N/A
	X Walk 1 Direction	To SW		X Walk 2 Direction	N/A
N/A	X Walk 1 Width (in)	108.0	N/A	X Walk 2 Width (in)	N/A
	X Walk 1 Slope (%)	2.4		X Walk 2 Slope (%)	N/A
	X Walk 1 X Slope (%)	5.8		X Walk 2 X Slope (%)	N/A

N/A	Ramp inside XWalk1?	Yes	N/A	Ramp inside XWalk2?	N/A
	Road Slope (%)	N/A	N/A	Clear Space?	N/A
	Road X Slope (%)	N/A	N/A	Clear Space to XWalk (in)	N/A
N/A	Any Obstructions?	N/A	N/A	Storm Grate/Utility Hazard?	N/A
	Obstruction Type			Storm Grate/Utility Type	
		N/A			N/A
		Yes		Surface Condition? (G/P)	Good

Remove & Replace Entire Ramp.
