Access Compliance Report

Public Rights-of-Way

(Curb Ramps)

Intersection ID: 11456	Main Street: E_W_T_HARRIS_BV	Cross Street: ROSECROFT_DR	Location:	N
ADA ID: AC89D6DD5084	Ramp Type: PerpDiag	Initial Pass/Fail: Fail	Overall Compliance: No	Severity Score: 35

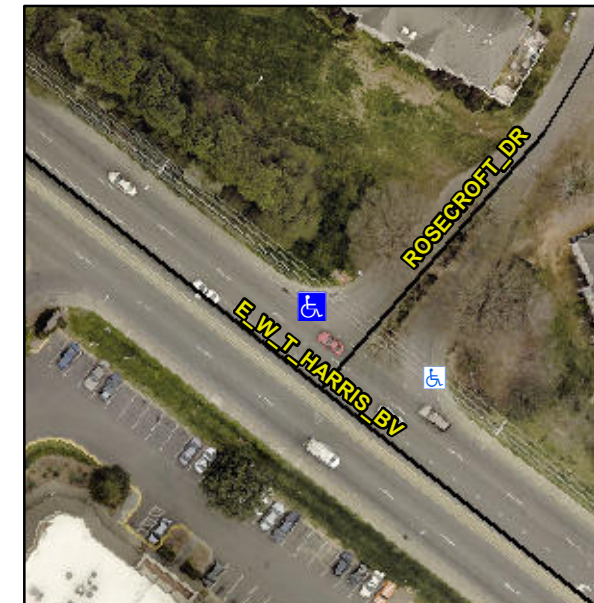
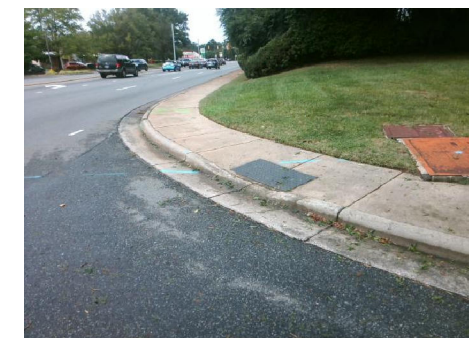
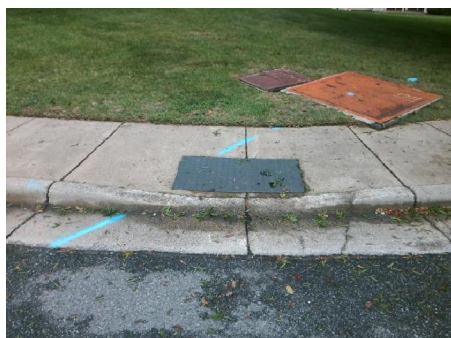
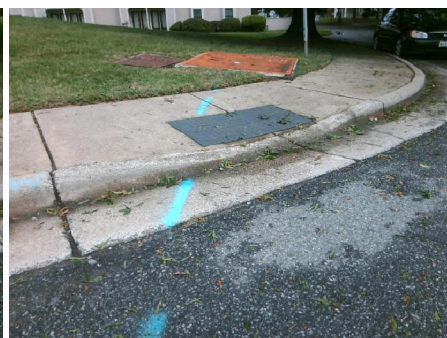
Not Found, R304.5.1, R304.2.2, R304.5.3

Compliance	Description	Data	Compliance	Description	Data
N/A	Ramp Length (in)	60.0	No	Ramp Slope (%)	12.9
No	Ramp Width (in)	41.0	No	Ramp XSlope (%)	2.9
N/A	Flare Type LT	N/A	N/A	Flare Type RT	N/A
N/A	Flare Slope LT (%)	N/A	N/A	Flare Slope RT (%)	N/A
N/A	Flare Traversable LT?	N/A	N/A	Flare Traversable RT?	N/A
N/A	Landing Length (in)	N/A	N/A	DWS Provided?	N/A
N/A	Landing Width (in)	N/A	N/A	DWS Contrast?	N/A
N/A	Landing Slope (%)	N/A	N/A	DWS Length (in)	N/A
N/A	Landing X Slope (%)	N/A	N/A	DWS Full Width?	N/A
N/A	Landing Curb? (Y/N)	N/A	N/A	DWS Offset (in)	N/A
N/A	Shared Landing?	N/A			
N/A	Gutter Ponding?	N/A	N/A	Gutter Slope (%)	N/A
N/A	Gutter Lip Ht (in)	N/A	N/A	Gutter X Slope (%)	N/A
N/A	Painted X Walk1?	No	N/A	Painted X Walk2?	No
	X Walk 1 Direction	To SW		X Walk 2 Direction	To SE
N/A	X Walk 1 Width (in)	N/A	N/A	X Walk 2 Width (in)	N/A
	X Walk 1 Slope (%)	3.9		X Walk 2 Slope (%)	2.3
	X Walk 1 X Slope (%)	1.1		X Walk 2 X Slope (%)	1.4

N/A	Ramp inside XWalk1?	N/A	N/A	Ramp inside XWalk2?	N/A
	Road Slope (%)	2.3	N/A	Clear Space?	N/A
	Road X Slope (%)	0.5	N/A	Clear Space to XWalk (in)	N/A
N/A	Any Obstructions?	N/A	N/A	Storm Grate/Utility Hazard?	N/A
	Obstruction Type			Storm Grate/Utility Type	
		N/A			N/A
			Yes	Surface Condition? (G/P)	Good

Remove & Replace Curb Ramp With Two New Directional Ramps or Equivalent.
