## Access Compliance Report Public Rights-of-Way (Curb Ramps)

Intersection ID: 11124	Main Street: N_CLARKSON_ST			Street:	CATES_ST	Location:	S		
ADA ID: AC8AEF2C33DE	Ramp Ty	Ramp Type: PerpDiag			Initial Pass/Fail: Fail Overall Compliance: No				37.5
Codes/Mitigation Info/Possible Solution				Field Measurements/Component Compliance					
	F	Possible Solutions:		Compliance Description		Data Compliance Description		Data	
4		Remove & Replace Curb Ramp	With	N/A	Ramp Length (in)	48.0	No	Ramp Slope (%)	9.7
		Two New Directional Ramps or Equivalent.		Yes	Ramp Width (in)	72.0	No	Ramp XSlope (%)	8.6
				N/A	Flare Type LT	N/A	N/A	Flare Type RT	N/A
				N/A	Flare Slope LT (%)	N/A	N/A	Flare Slope RT (%)	N/A
				N/A	Flare Traversable LT?	N/A	N/A	Flare Traversable RT?	N/A
	and has a set			N/A	Landing Length (in)	N/A	N/A	DWS Provided?	N/A

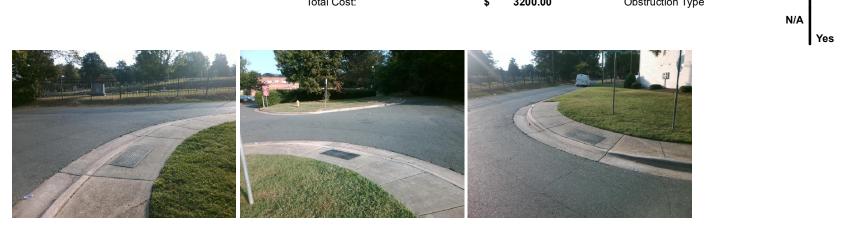
t.		Surveyor Notes:		N/A	Landing Width (in)	N/A	N/A	DWS Contrast?	N/A
		N/A		N/A	Landing Slope (%)	N/A	N/A	DWS Length (in)	N/A
				N/A	Landing X Slope (%)	N/A	N/A	DWS Full Width?	N/A
St Alle	Real : Mary			N/A	Landing Curb? (Y/N)	N/A	N/A	DWS Offset (in)	N/A
	A BAR AND			N/A	Shared Landing?	N/A			
ST AND MARK	1 B	PROW/ADA:		N/A	Gutter Ponding?	N/A	N/A	Gutter Slope (%)	N/A
SP 1 1 1	A State	Not Found, R304.2.2, R304.5.3		N/A	Gutter Lip Ht (in)	N/A	N/A	Gutter X Slope (%)	N/A
	No 1 Pr	· · ·		N/A	Painted X Walk1?	No	N/A	Painted X Walk2?	No
A MARIA	Maral 1				X Walk 1 Direction	To E		X Walk 2 Direction	To N
Com 1/3 Cart				N/A	X Walk 1 Width (in)	N/A	N/A	X Walk 2 Width (in)	N/A
Street 1 Name	CATES ST				X Walk 1 Slope (%)	4.6		X Walk 2 Slope (%)	0.8
Stop Condition-Street 2	None				X Walk 1 X Slope (%)	2.3		X Walk 2 X Slope (%)	5.9
Street 2 Name	N CLARKSON ST			N/A	Ramp inside XWalk1?	N/A	N/A	Ramp inside XWalk2?	N/A

Stop Condition-Street 1	StopSign				Road Slope (%)	5.8	N/A	Clear Space?	N/A
					Road X Slope (%)	6.2	N/A	Clear Space to XWalk (in)	N/A
				N/A	Any Obstructions?	N/A	N/A	Storm Grate/Utility Hazard?	N/A
		Total Cost: \$	3200.00		Obstruction Type			Storm Grate/Utility Type	
						N/A			N/A
