Access Compliance Report

Public Rights-of-Way

(Curb Ramps)

| Intersection ID: 4968 | Main Street: CARMATHEN_RD | Cross Street: GLAMORGAN_CT | Location: SW |

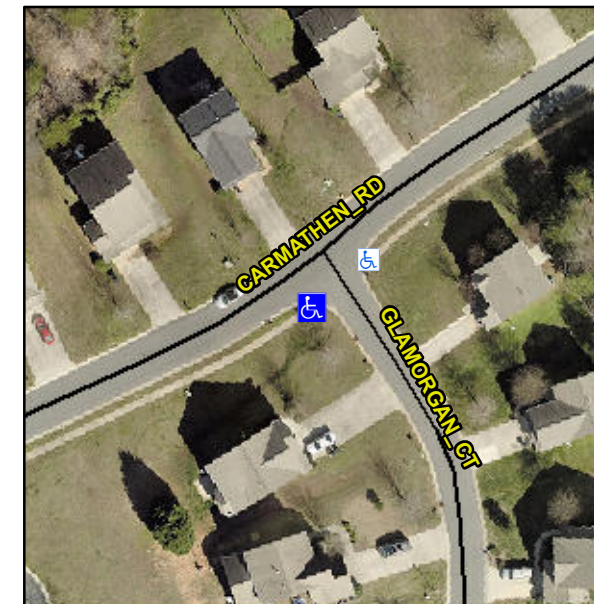
| ADA ID: AC9C326D73E9 | Ramp Type: Perp | Initial Pass/Fail: Fail | Overall Compliance: No |
| Severity Score: 10 | | | |

R304.5.1, R304.5.3

| Compliance | Description | Data | Compliance | Description | Data |
|---|---|---|---|---|---|
| No | Ramp Width (in) | 44.0 | No | Ramp XSlope (%) | 3.5 |

Remove & Replace Entire Ramp.

Total Cost: \$ 1850.00
