Access Compliance Report

Public Rights-of-Way

(Curb Ramps)

| Intersection ID: 17285 | Main Street: WESTMINSITER_PL | Cross Street: SHARON_RD | Location: E |

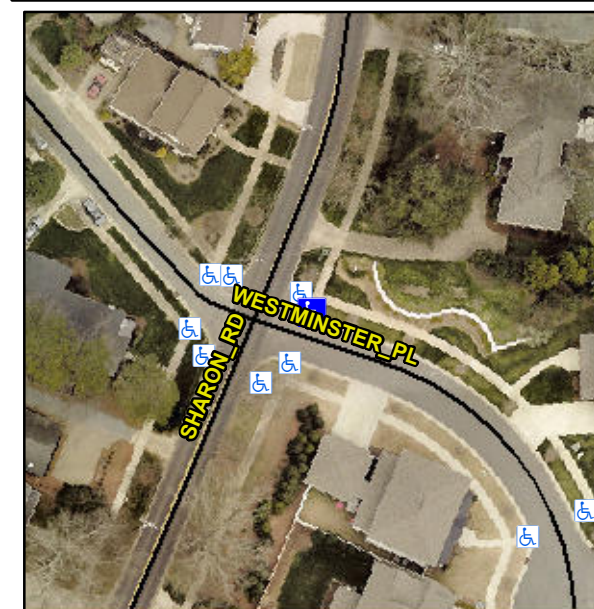
| ADA ID: AC9FA1F32843 | Ramp Type: Perp | Initial Pass/Fail: Fail | Overall Compliance: No |
| Severity Score: 1.25 | | | |

R304.5.3

| Compliance | Description | Data | Compliance | Description | Data |
|---|---|---|---|---|---|
| Yes | Ramp Width (in) | 48.0 | No | Ramp XSlope (%) | 3.9 |

Remove & Replace Entire Ramp.

Total Cost: \$ 1850.00
