Access Compliance Report

Public Rights-of-Way

(Curb Ramps)

Intersection ID: 28629	Main Street: DEARMON_RD	Cross Street: EAGLE_CREEK_DR	Location: E
ADA ID: ACB2B6BA8E61	Ramp Type: Perp	Initial Pass/Fail: Fail	Overall Compliance: No
			Severity Score: 46.25

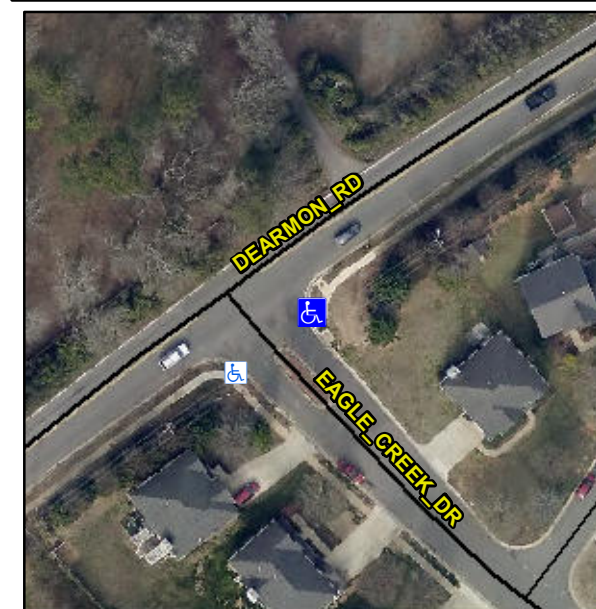
R304.5.1, R304.2.2, R304.5.3

Compliance	Description	Data	Compliance	Description	Data
N/A	Ramp Length (in)	65.0	No	Ramp Slope (%)	14.6
No	Ramp Width (in)	47.0	No	Ramp XSlope (%)	6.7
N/A	Flare Type LT	N/A	N/A	Flare Type RT	N/A
N/A	Flare Slope LT (%)	N/A	N/A	Flare Slope RT (%)	N/A
N/A	Flare Traversable LT?	N/A	N/A	Flare Traversable RT?	N/A
N/A	Landing Length (in)	N/A	N/A	DWS Provided?	N/A
N/A	Landing Width (in)	N/A	N/A	DWS Contrast?	N/A
N/A	Landing Slope (%)	N/A	N/A	DWS Length (in)	N/A
N/A	Landing X Slope (%)	N/A	N/A	DWS Full Width?	N/A
N/A	Landing Curb? (Y/N)	N/A	N/A	DWS Offset (in)	N/A
N/A	Shared Landing?	N/A			
N/A	Gutter Ponding?	N/A	N/A	Gutter Slope (%)	N/A
N/A	Gutter Lip Ht (in)	N/A	N/A	Gutter X Slope (%)	N/A
N/A	Painted X Walk1?	No	N/A	Painted X Walk2?	N/A
	X Walk 1 Direction	To SW		X Walk 2 Direction	N/A
N/A	X Walk 1 Width (in)	N/A	N/A	X Walk 2 Width (in)	N/A
	X Walk 1 Slope (%)	8.2		X Walk 2 Slope (%)	N/A
	X Walk 1 X Slope (%)	2.7		X Walk 2 X Slope (%)	N/A

N/A	Ramp inside XWalk1?	N/A	N/A	Ramp inside XWalk2?	N/A
	Road Slope (%)	N/A	N/A	Clear Space?	N/A
	Road X Slope (%)	N/A	N/A	Clear Space to XWalk (in)	N/A
N/A	Any Obstructions?	N/A	N/A	Storm Grate/Utility Hazard?	N/A
	Obstruction Type			Storm Grate/Utility Type	
		N/A			N/A
			Yes	Surface Condition? (G/P)	Good

Possible Solutions:

Remove & Replace Entire Ramp.
