# Access Compliance Report

## Public Rights-of-Way

### (Curb Ramps)

Intersection ID: 9519	Main Street: FAIRFIELD_ST	Cross Street: OAKLAWN_AV	Location: SE
ADA ID: ACEAEEBDC28A	Ramp Type: Perp	Initial Pass/Fail: Fail	Overall Compliance: No
Severity Score: 13.75			
Codes/Mitigation Info/Possible Solution		Field Measurements/Component Compliance

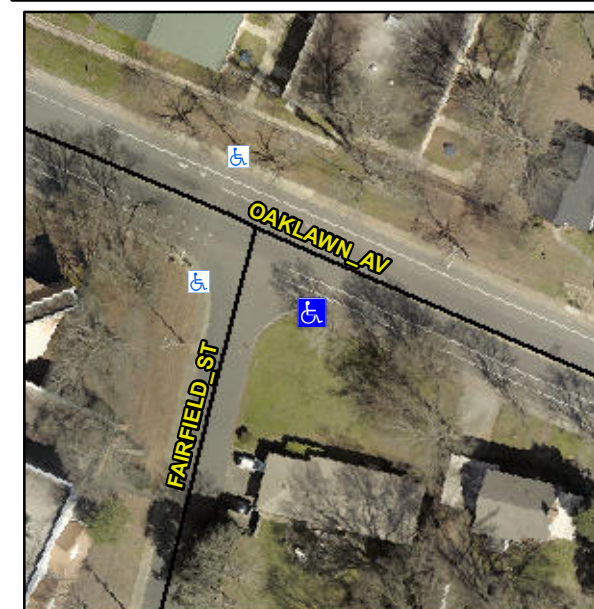
**Not Found, R304.2.2, R304.5.3**

Compliance	Description	Data	Compliance	Description	Data
N/A	Ramp Length (in)	29.0	No	Ramp Slope (%)	8.8
Yes	Ramp Width (in)	60.0	No	Ramp XSlope (%)	4.7
N/A	Flare Type LT	N/A	N/A	Flare Type RT	N/A
N/A	Flare Slope LT (%)	N/A	N/A	Flare Slope RT (%)	N/A
N/A	Flare Traversable LT?	N/A	N/A	Flare Traversable RT?	N/A
N/A	Landing Length (in)	N/A	N/A	DWS Provided?	N/A
N/A	Landing Width (in)	N/A	N/A	DWS Contrast?	N/A
N/A	Landing Slope (%)	N/A	N/A	DWS Length (in)	N/A
N/A	Landing X Slope (%)	N/A	N/A	DWS Full Width?	N/A
N/A	Landing Curb? (Y/N)	N/A	N/A	DWS Offset (in)	N/A
N/A	Shared Landing?	N/A			
N/A	Gutter Ponding?	N/A	N/A	Gutter Slope (%)	N/A
N/A	Gutter Lip Ht (in)	N/A	N/A	Gutter X Slope (%)	N/A
N/A	Painted X Walk1?	No	N/A	Painted X Walk2?	N/A
	X Walk 1 Direction	To NW		X Walk 2 Direction	N/A
N/A	X Walk 1 Width (in)	N/A	N/A	X Walk 2 Width (in)	N/A
	X Walk 1 Slope (%)	2.0		X Walk 2 Slope (%)	N/A
	X Walk 1 X Slope (%)	0.5		X Walk 2 X Slope (%)	N/A

N/A	Ramp inside XWalk1?	N/A	N/A	Ramp inside XWalk2?	N/A
	Road Slope (%)	N/A	N/A	Clear Space?	N/A
	Road X Slope (%)	N/A	N/A	Clear Space to XWalk (in)	N/A
N/A	Any Obstructions?	N/A	N/A	Storm Grate/Utility Hazard?	N/A
	Obstruction Type			Storm Grate/Utility Type	
		N/A			N/A
		Yes		Surface Condition? (G/P)	Good

**Remove & Replace Entire Ramp.**

Total Cost: \$ 1850.00
