# Access Compliance Report

## Public Rights-of-Way

### (Curb Ramps)

Intersection ID: 30106	Main Street: HARLAND_ST	Cross Street: LARWILL_LN	Location: NW
ADA ID: ACED68D56EFD	Ramp Type: PerpDiag	Initial Pass/Fail: Fail	Overall Compliance: No
		Severity Score: 10

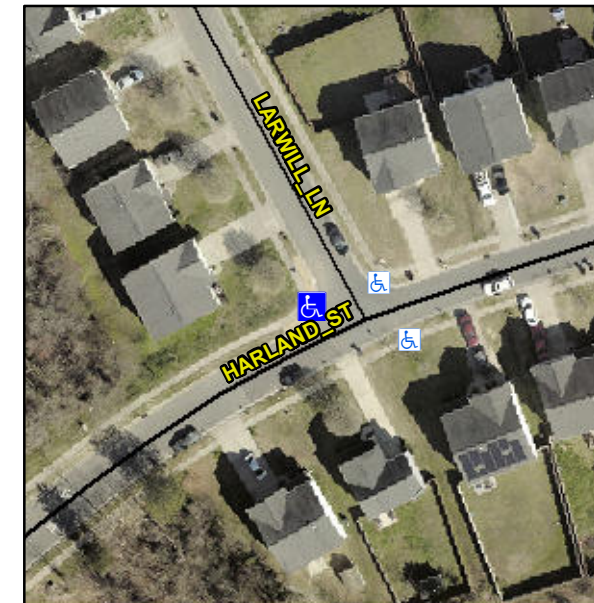
**Not Found, R304.5.1, R304.5.3**

Compliance	Description	Data	Compliance	Description	Data
N/A	Ramp Length (in)	48.0	Yes	Ramp Slope (%)	5.4
No	Ramp Width (in)	42.0	No	Ramp XSlope (%)	4.1
N/A	Flare Type LT	N/A	N/A	Flare Type RT	N/A
N/A	Flare Slope LT (%)	N/A	N/A	Flare Slope RT (%)	N/A
N/A	Flare Traversable LT?	N/A	N/A	Flare Traversable RT?	N/A
N/A	Landing Length (in)	N/A	N/A	DWS Provided?	N/A
N/A	Landing Width (in)	N/A	N/A	DWS Contrast?	N/A
N/A	Landing Slope (%)	N/A	N/A	DWS Length (in)	N/A
N/A	Landing X Slope (%)	N/A	N/A	DWS Full Width?	N/A
N/A	Landing Curb? (Y/N)	N/A	N/A	DWS Offset (in)	N/A
N/A	Shared Landing?	N/A			
N/A	Gutter Ponding?	N/A	N/A	Gutter Slope (%)	N/A
N/A	Gutter Lip Ht (in)	N/A	N/A	Gutter X Slope (%)	N/A
N/A	Painted X Walk1?	No	N/A	Painted X Walk2?	No
	X Walk 1 Direction	To S		X Walk 2 Direction	To E
N/A	X Walk 1 Width (in)	N/A	N/A	X Walk 2 Width (in)	N/A
	X Walk 1 Slope (%)	3.6		X Walk 2 Slope (%)	8.0
	X Walk 1 X Slope (%)	4.9		X Walk 2 X Slope (%)	0.2

N/A	Ramp inside XWalk1?	N/A	N/A	Ramp inside XWalk2?	N/A
	Road Slope (%)	3.1	N/A	Clear Space?	N/A
	Road X Slope (%)	7.2	N/A	Clear Space to XWalk (in)	N/A
N/A	Any Obstructions?	N/A	N/A	Storm Grate/Utility Hazard?	N/A
	Obstruction Type			Storm Grate/Utility Type	
		N/A			N/A
			Yes	Surface Condition? (G/P)	Good

**Remove & Replace Curb Ramp With Two New Directional Ramps or Equivalent.**

Total Cost: \$ 3200.00
