Access Compliance Report Public Rights-of-Way (Curb Ramps)

Intersection ID: N/A Main Street: WILTHSHIRE_MANOR_DR **Cross Street: HATTON CROSS DR** Location: NE ADA ID: AD07E953ABA5 Ramp Type: BlendTrans2 Initial Pass/Fail: Fail **Overall Compliance: No Severity Score:** 8.75

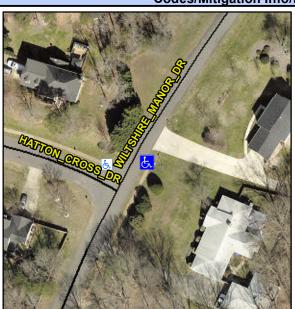
ASP LIP 1.5

Not Found, R304.5.1

Field Measurements/Component Compliance						
Compliance Description		Data	Compl	iance Description	Data	
N/A	Ramp Length (in)	90.0	Yes	BlendTrans Slope (%)	2.0	
No	Ramp Width (in)	44.5	Yes	BlendTrans XSlope (%)	1.3	
N/A	Flare Type LT	N/A	N/A	Flare Type RT	N/A	
N/A	Flare Slope LT (%)	N/A	N/A	Flare Slope RT (%)	N/A	
N/A	Flare Traversable LT?	N/A	N/A	Flare Traversable RT?	N/A	
N/A	Landing Length (in)	N/A	N/A	DWS Provided?	N/A	
N/A	Landing Width (in)	N/A	N/A	DWS Contrast?	N/A	
N/A	Landing Slope (%)	N/A	N/A	DWS Length (in)	N/A	
N/A	Landing X Slope (%)	N/A	N/A	DWS Full Width?	N/A	
N/A	Landing Curb? (Y/N)	N/A	N/A	DWS Offset (in)	N/A	
N/A	Shared Landing?	N/A				
N/A	Gutter Ponding?	N/A	N/A	Gutter Slope (%)	N/A	
N/A	Gutter Lip Ht (in)	N/A	N/A	Gutter X Slope (%)	N/A	
N/A	Painted X Walk1?	No	N/A	Painted X Walk2?	N/A	
	X Walk 1 Direction	To W		X Walk 2 Direction	N/A	
	X Walk 1 Width (in)	N/A		X Walk 2 Width (in)	N/A

X Walk 1 Slope (%)	2.5		X Walk 2 Slope (%)	N/A	
	X Walk 1 X Slope (%)	0.9		X Walk 2 X Slope (%)	N/A	
N/A	Ramp inside XWalk1?	N/A	N/A	Ramp inside XWalk2?	N/A	
	Road Slope (%)	0.9		Clear Space?	N/A	
	Road X Slope (%)	2.5	N/A	Clear Space to XWalk (in)	N/A	
N/A	Any Obstructions?	N/A	N/A	Storm Grate/Utility Hazard?	N/A	
	Obstruction Type			Storm Grate/Utility Type		
		N/A			N/A	
			Yes	Surface Condition? (G/P)	Good	
			No	Curb Slope (%)	5.3

Remove & Replace Curb Ramp With Two New Directional Ramps or Equivalent.
