Access Compliance Report Public Rights-of-Way (Curb Ramps)

Intersection ID: 16395Main Street:SPLIT_OAK_DRCross Street:BALD RIDGE_DRLocation:NEADA ID: AD0AE83216A1Ramp Type:PerpDiagInitial Pass/Fail:PassOverall Compliance:NoSeverity Score:27.5

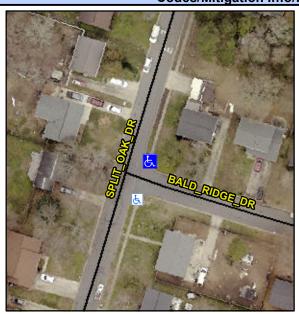
Not Found, R304.2.1, R304.2.2-Perp, R304.3.2-Para, R304.5.3, R304.2.3, R305, R304.5.4

Compliance Description		Data	Compliance Description		Data
N/A	Ramp Length (in)	96.0	Yes	Ramp Slope (%)	8.0
Yes	Ramp Width (in)	48.0	Yes	Ramp XSlope (%)	0.9
N/A	Flare Type LT	Sloped	N/A	Flare Type RT	N/A
N/A	Flare Slope LT (%)	10.3	N/A	Flare Slope RT (%)	5.7
N/A	Flare Traversable LT?	Yes	N/A	Flare Traversable RT?	No
No	Landing Length (in)	N/A	No	DWS Provided?	No
No	Landing Width (in)	N/A	N/A	DWS Contrast?	No
No	Landing Slope (%)	N/A	N/A	DWS Length (in)	N/A
No	Landing X Slope (%)	N/A	N/A	DWS Full Width?	No
N/A	Landing Curb? (Y/N)	No	N/A	DWS Offset (in)	N/A
N/A	Shared Landing?	N/A			
Yes	Gutter Ponding?	No	No	Gutter Slope (%)	13.7
Yes	Gutter Lip Ht (in)	0.0	Yes	Gutter X Slope (%)	0.2
N/A	Painted X Walk1?	No	N/A	Painted X Walk2?	No
	X Walk 1 Direction	To W		X Walk 2 Direction	To SW
N/A	X Walk 1 Width (in)	N/A	N/A	X Walk 2 Width (in)	N/A
	X Walk 1 Slope (%)	2.7		X Walk 2 Slope (%)	1.2
	X Walk 1 X Slope (%)	0.5		X Walk 2 X Slope (%)	2.6

N/A	Ramp inside XWalk1?	N/A	N/A	Ramp inside XWalk2?	N/A
	Road Slope (%)	0.1	N/A	Clear Space?	Yes
	Road X Slope (%)	2.6	N/A	Clear Space to XWalk (in)	N/A
Yes	Any Obstructions?	No	Yes	Storm Grate/Utility Hazard?	No
	Obstruction Type			Storm Grate/Utility Type	
		N/A			N/A
			Yes	Surface Condition? (G/P)	Good

Remove & Replace Curb Ramp With Two New Directional Ramps or Equivalent. Remove & Replace Gutter.
