# Access Compliance Report

## Public Rights-of-Way

### (Curb Ramps)

| Intersection ID: 8239 | Main Street: STATESVILLE_AV | Cross Street: WHITTINGTON_ST | Location: SW |

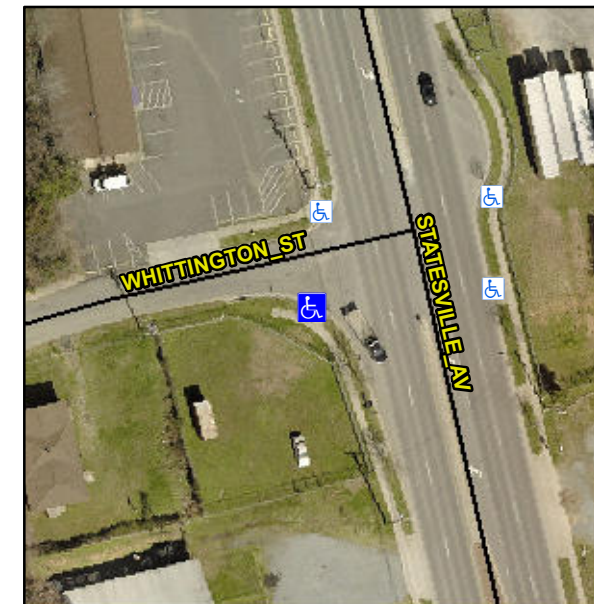
| ADA ID: AD174995D841 | Ramp Type: PerpDiag | Initial Pass/Fail: Fail | Overall Compliance: No |

**Not Found, R304.5.1, R304.2.2, R304.5.3**

| Compliance | Description | Data | Compliance | Description | Data |
|---|---|---|---|---|---|
| N/A | Ramp Length (in) | 59.0 | No | Ramp Slope (%) | 10.8 |
| No | Ramp Width (in) | 43.0 | No | Ramp XSlope (%) | 3.1 |

**Remove & Replace Curb Ramp With Two New Directional Ramps or Equivalent.**
