# Access Compliance Report

## Public Rights-of-Way

### (Curb Ramps)

Intersection ID: 6911	Main Street: CINDY_LN	Cross Street: CINDY_PARK_DR	Location: SW
ADA ID: AD246EF5F6C7	Ramp Type: Perp	Initial Pass/Fail: Fail	Overall Compliance: No
		Severity Score: 10

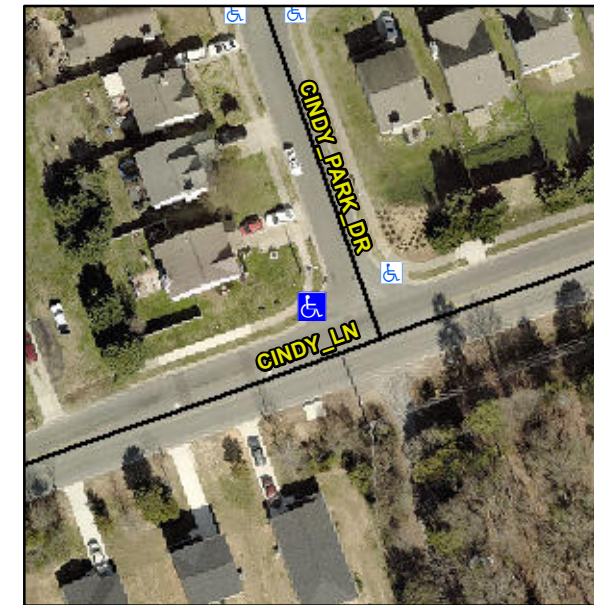
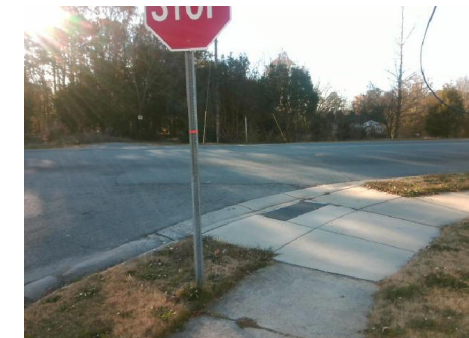
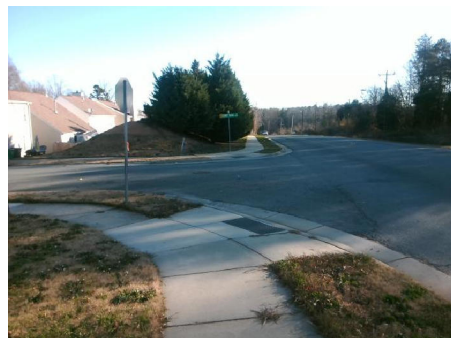
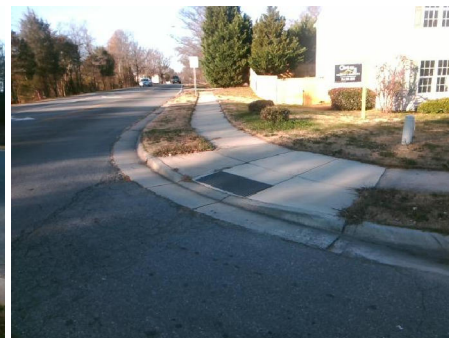
**Not Found, R304.5.1, R304.5.3**

Compliance	Description	Data	Compliance	Description	Data
N/A	Ramp Length (in)	50.5	Yes	Ramp Slope (%)	7.1
No	Ramp Width (in)	46.0	No	Ramp XSlope (%)	4.7
N/A	Flare Type LT	N/A	N/A	Flare Type RT	N/A
N/A	Flare Slope LT (%)	N/A	N/A	Flare Slope RT (%)	N/A
N/A	Flare Traversable LT?	N/A	N/A	Flare Traversable RT?	N/A
N/A	Landing Length (in)	N/A	N/A	DWS Provided?	N/A
N/A	Landing Width (in)	N/A	N/A	DWS Contrast?	N/A
N/A	Landing Slope (%)	N/A	N/A	DWS Length (in)	N/A
N/A	Landing X Slope (%)	N/A	N/A	DWS Full Width?	N/A
N/A	Landing Curb? (Y/N)	N/A	N/A	DWS Offset (in)	N/A
N/A	Shared Landing?	N/A			
N/A	Gutter Ponding?	N/A	N/A	Gutter Slope (%)	N/A
N/A	Gutter Lip Ht (in)	N/A	N/A	Gutter X Slope (%)	N/A
N/A	Painted X Walk1?	No	N/A	Painted X Walk2?	N/A
	X Walk 1 Direction	To E		X Walk 2 Direction	N/A
N/A	X Walk 1 Width (in)	N/A	N/A	X Walk 2 Width (in)	N/A
	X Walk 1 Slope (%)	1.4		X Walk 2 Slope (%)	N/A
	X Walk 1 X Slope (%)	1.8		X Walk 2 X Slope (%)	N/A

N/A	Ramp inside XWalk1?	N/A	N/A	Ramp inside XWalk2?	N/A
	Road Slope (%)	N/A	N/A	Clear Space?	N/A
	Road X Slope (%)	N/A	N/A	Clear Space to XWalk (in)	N/A
N/A	Any Obstructions?	N/A	N/A	Storm Grate/Utility Hazard?	N/A
	Obstruction Type			Storm Grate/Utility Type	
		N/A			N/A
		Yes		Surface Condition? (G/P)	Good

**Remove & Replace Entire Ramp.**

Total Cost: \$ 1850.00
