Access Compliance Report

Public Rights-of-Way

(Curb Ramps)

Intersection ID: 26464	Main Street: BEVINGTON_PL	Cross Street: ENCLAVE_PL	Location: NW
ADA ID: AD3123631F54	Ramp Type: PerpDiag	Initial Pass/Fail: Fail	Overall Compliance: No
Severity Score: 25			
Codes/Mitigation Info/Possible Solution		Field Measurements/Component Compliance

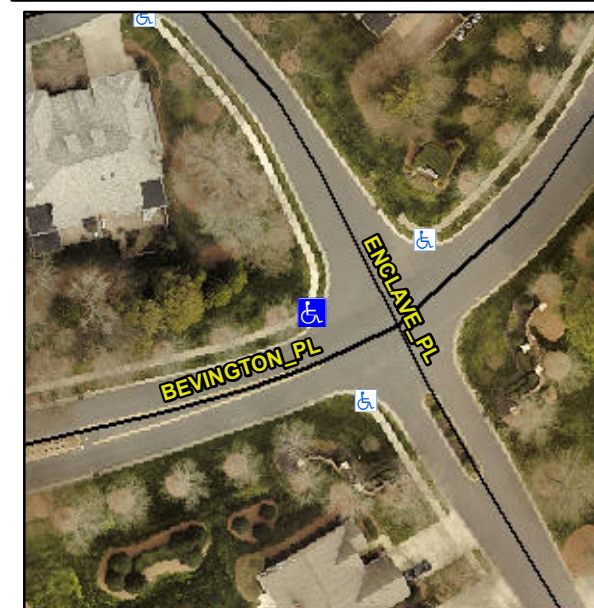
Not Found, R304.5.3

Compliance	Description	Data	Compliance	Description	Data
N/A	Ramp Length (in)	96.0	Yes	Ramp Slope (%)	5.2
Yes	Ramp Width (in)	48.0	No	Ramp XSlope (%)	10.0
N/A	Flare Type LT	N/A	N/A	Flare Type RT	N/A
N/A	Flare Slope LT (%)	N/A	N/A	Flare Slope RT (%)	N/A
N/A	Flare Traversable LT?	N/A	N/A	Flare Traversable RT?	N/A
N/A	Landing Length (in)	N/A	N/A	DWS Provided?	N/A
N/A	Landing Width (in)	N/A	N/A	DWS Contrast?	N/A
N/A	Landing Slope (%)	N/A	N/A	DWS Length (in)	N/A
N/A	Landing X Slope (%)	N/A	N/A	DWS Full Width?	N/A
N/A	Landing Curb? (Y/N)	N/A	N/A	DWS Offset (in)	N/A
N/A	Shared Landing?	N/A			
N/A	Gutter Ponding?	N/A	N/A	Gutter Slope (%)	N/A
N/A	Gutter Lip Ht (in)	N/A	N/A	Gutter X Slope (%)	N/A
N/A	Painted X Walk1?	No	N/A	Painted X Walk2?	No
	X Walk 1 Direction	To SE		X Walk 2 Direction	To NE
N/A	X Walk 1 Width (in)	N/A	N/A	X Walk 2 Width (in)	N/A
	X Walk 1 Slope (%)	1.5		X Walk 2 Slope (%)	6.3
	X Walk 1 X Slope (%)	6.2		X Walk 2 X Slope (%)	5.1

N/A	Ramp inside XWalk1?	N/A	N/A	Ramp inside XWalk2?	N/A
	Road Slope (%)	6.5	N/A	Clear Space?	N/A
	Road X Slope (%)	1.5	N/A	Clear Space to XWalk (in)	N/A
N/A	Any Obstructions?	N/A	N/A	Storm Grate/Utility Hazard?	N/A
	Obstruction Type			Storm Grate/Utility Type	
		N/A			N/A
			Yes	Surface Condition? (G/P)	Good

Possible Solutions:

Remove & Replace Curb Ramp With Two New Directional Ramps or Equivalent.
