## **Access Compliance Report Public Rights-of-Way** (Curb Ramps)

Intersection ID: 43642 Main Street: CEDAR CROSSINGS DR Cross Street: HUNTINGTON\_MEADOW\_LN Location: SE ADA ID: AD50FC267493 Ramp Type: Perp Initial Pass/Fail: Pass **Overall Compliance: No** Severity Score: 20.25

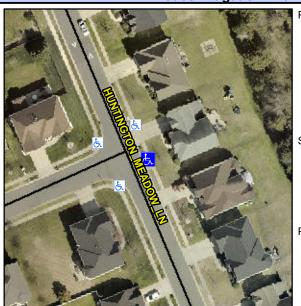
Field Measurements/Component Compliance							
Compliance Description		Data	Compliance Description		Data		
N/A	Ramp Length (in)	97.0	Yes	Ramp Slope (%)	5.2		
Yes	Ramp Width (in)	49.0	No	Ramp XSlope (%)	2.7		
N/A	Flare Type LT	Sloped	N/A	Flare Type RT	N/A		
N/A	Flare Slope LT (%)	2.7	N/A	Flare Slope RT (%)	5.5		
N/A	Flare Traversable LT?	No	N/A	Flare Traversable RT?	No		
No	Landing Length (in)	N/A	No	DWS Provided?	No		
No	Landing Width (in)	N/A	N/A	DWS Contrast?	No		
No	Landing Slope (%)	N/A	N/A	DWS Length (in)	N/A		
No	Landing X Slope (%)	N/A	N/A	DWS Full Width?	No		
N/A	Landing Curb? (Y/N)	No	N/A	DWS Offset (in)	N/A		
N/A	Shared Landing?	No					
Yes	Gutter Ponding?	No	Yes	Gutter Slope (%)	4.5		
Yes	Gutter Lip Ht (in)	0.0	Yes	Gutter X Slope (%)	0.9		
N/A	Painted X Walk1?	No	N/A	Painted X Walk2?	N/A		
	X Walk 1 Direction	To W		X Walk 2 Direction	N/A		
N/A	X Walk 1 Width (in)	N/A	N/A	X Walk 2 Width (in)	N/A

X Walk 1 Slope (%)	1.9		X Walk 2 Slope (%)	N/A		
	X Walk 1 X Slope (%)	1.6		X Walk 2 X Slope (%)	N/A		
N/A	Ramp inside XWalk1?	N/A	N/A	Ramp inside XWalk2?	N/A		
	Road Slope (%)	N/A	N/A	Clear Space?	Yes		
	Road X Slope (%)	N/A	N/A	Clear Space to XWalk (in)	N/A		
Yes	Any Obstructions?	No	Yes	Storm Grate/Utility Hazard?	No		
	Obstruction Type			Storm Grate/Utility Type			
		N/A			N/A		
			Yes	Surface Condition? (G/P)	Good

Possible Solutions: Remove & Replace Entire Ramp. Surveyor Notes: N/A PROW/ADA: Not Found, R304.5.3, R304.2.1, R304.2.2-Perp, R304.3.2-Para, R305
