# Access Compliance Report

## Public Rights-of-Way (Curb Ramps)

| Intersection ID: 9560 | Main Street: LUCKY_PENNY_ST | Cross Street: FREEDOM_DR | Location: SE |
| ADA ID: AD568241A202 | Ramp Type: Perp | Initial Pass/Fail: Fail | Overall Compliance: No |

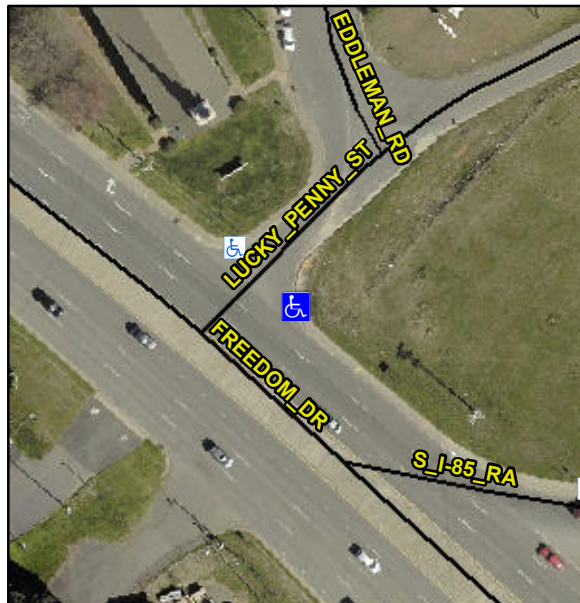
**Not Found, R304.5.1, R304.2.2, R304.5.3**

| Compliance | Description | Data | Compliance | Description | Data |
|---|---|---|---|---|---|
| N/A | Ramp Length (in) | 48.0 | No | Ramp Slope (%) | 10.3 |
| No | Ramp Width (in) | 40.0 | No | Ramp XSlope (%) | 3.3 |

**Remove & Replace Entire Ramp.**
