Intersection ID: 23899	Main Street: CARTGATE_LN	Cross Street: STEPHENDALE_DR	Location:	N
ADA ID: AD5B5B9B0A33	Ramp Type: PerpDiag	Initial Pass/Fail: Fail	Overall Compliance: No	Severity Score: 22.5

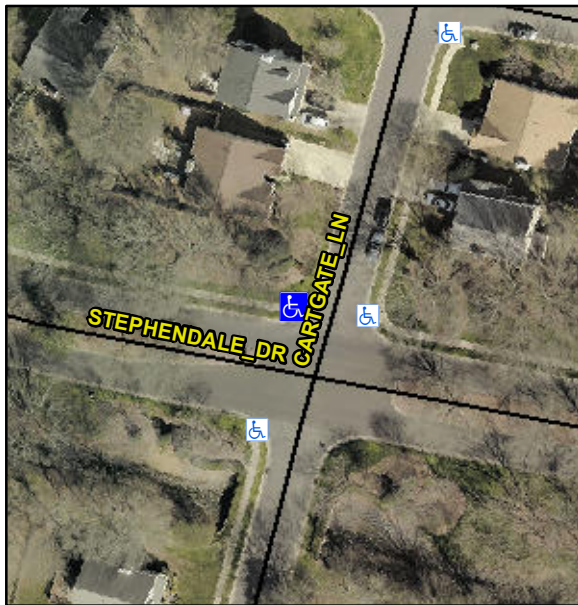
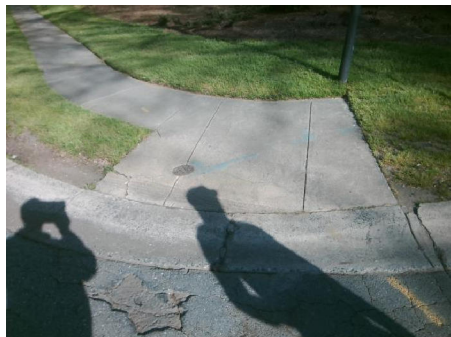
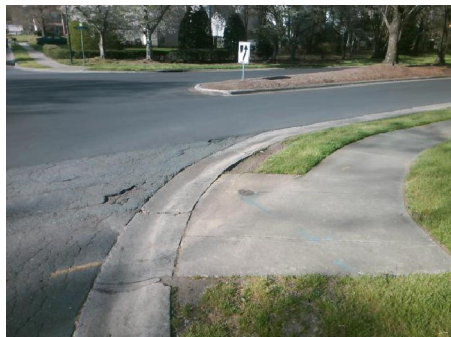
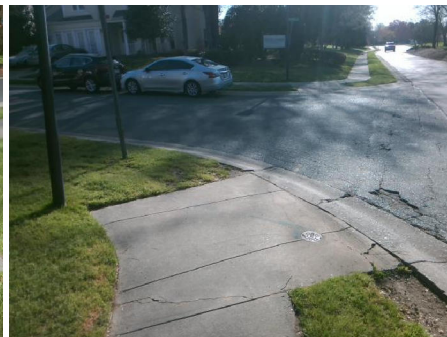
R304.5.1, R304.2.2, R304.5.3

Compliance	Description	Data	Compliance	Description	Data
N/A	Ramp Length (in)	95.0	No	Ramp Slope (%)	11.5
No	Ramp Width (in)	47.0	No	Ramp XSlope (%)	3.2
N/A	Flare Type LT	N/A	N/A	Flare Type RT	N/A
N/A	Flare Slope LT (%)	N/A	N/A	Flare Slope RT (%)	N/A
N/A	Flare Traversable LT?	N/A	N/A	Flare Traversable RT?	N/A
N/A	Landing Length (in)	N/A	N/A	DWS Provided?	N/A
N/A	Landing Width (in)	N/A	N/A	DWS Contrast?	N/A
N/A	Landing Slope (%)	N/A	N/A	DWS Length (in)	N/A
N/A	Landing X Slope (%)	N/A	N/A	DWS Full Width?	N/A
N/A	Landing Curb? (Y/N)	N/A	N/A	DWS Offset (in)	N/A
N/A	Shared Landing?	N/A			
N/A	Gutter Ponding?	N/A	N/A	Gutter Slope (%)	N/A
N/A	Gutter Lip Ht (in)	N/A	N/A	Gutter X Slope (%)	N/A
N/A	Painted X Walk1?	No	N/A	Painted X Walk2?	No
	X Walk 1 Direction	To SW		X Walk 2 Direction	To SE
N/A	X Walk 1 Width (in)	N/A	N/A	X Walk 2 Width (in)	N/A
	X Walk 1 Slope (%)	3.1		X Walk 2 Slope (%)	0.3
	X Walk 1 X Slope (%)	0.3		X Walk 2 X Slope (%)	2.3

N/A	Ramp inside XWalk1?	N/A	N/A	Ramp inside XWalk2?	N/A
	Road Slope (%)	0.1	N/A	Clear Space?	N/A
	Road X Slope (%)	2.8	N/A	Clear Space to XWalk (in)	N/A
N/A	Any Obstructions?	N/A	N/A	Storm Grate/Utility Hazard?	N/A
	Obstruction Type			Storm Grate/Utility Type	
		N/A			N/A
			Yes	Surface Condition? (G/P)	Good

Remove & Replace Curb Ramp With Two New Directional Ramps or Equivalent.
