Intersection ID: 6013	Main Street: BALANCING_ROCK_CT	Cross Street: CHIMNEY_ROCK_CT	Location:	N
ADA ID: AD68B251EEF4	Ramp Type: Perp	Initial Pass/Fail: Fail	Overall Compliance: No	Severity Score: 12.5

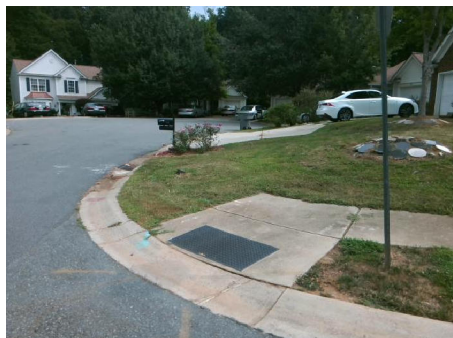
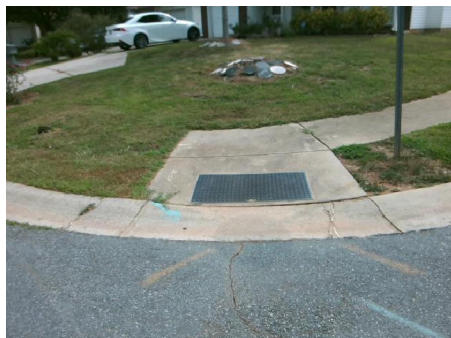
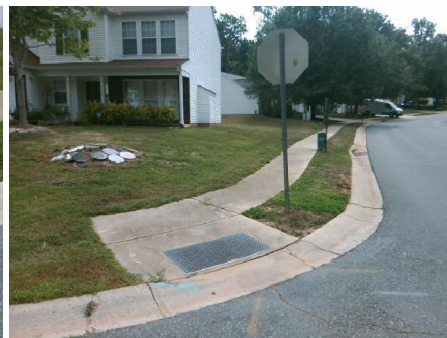
PROW/ADA:	Not Found, R304.2.2		N/A	Gutter Ponding?	N/A	N/A	Gutter Slope (%)	N/A
			N/A	Gutter Lip Ht (in)	0.5	N/A	Gutter X Slope (%)	N/A
			N/A	Painted X Walk1?	No	N/A	Painted X Walk2?	N/A
				X Walk 1 Direction	To S		X Walk 2 Direction	N/A
			N/A	X Walk 1 Width (in)	N/A	N/A	X Walk 2 Width (in)	N/A
				X Walk 1 Slope (%)	0.1		X Walk 2 Slope (%)	N/A
				X Walk 1 X Slope (%)	0.1		X Walk 2 X Slope (%)	N/A
			N/A	Ramp inside XWalk1?	N/A	N/A	Ramp inside XWalk2?	N/A
				Road Slope (%)	N/A	N/A	Clear Space?	N/A
				Road X Slope (%)	N/A	N/A	Clear Space to XWalk (in)	N/A
			N/A	Any Obstructions?	N/A	N/A	Storm Grate/Utility Hazard?	N/A
				Obstruction Type			Storm Grate/Utility Type	
Total Cost:	\$	1850.00			N/A			N/A
						Yes	Surface Condition? (G/P)	Good

Codes/Mitigation Info/Possible Solution			Field Measurements/Component Compliance					
<p>Street 1 Name CHIMNEY ROCK CT</p> <p>Stop Condition-Street 2 StopSign</p> <p>Street 2 Name N/A</p> <p>Stop Condition-Street 1 N/A</p>	Possible Solutions:		Compliance	Description	Data	Compliance	Description	Data
	Remove & Replace Entire Ramp.		N/A	Ramp Length (in)	45.0	No	Ramp Slope (%)	10.1
			Yes	Ramp Width (in)	48.0	Yes	Ramp XSlope (%)	1.9
			N/A	Flare Type LT	N/A	N/A	Flare Type RT	N/A
			N/A	Flare Slope LT (%)	N/A	N/A	Flare Slope RT (%)	N/A
			N/A	Flare Traversable LT?	N/A	N/A	Flare Traversable RT?	N/A
			N/A	Landing Length (in)	N/A	N/A	DWS Provided?	N/A
			N/A	Landing Width (in)	N/A	N/A	DWS Contrast?	N/A
			N/A	Landing Slope (%)	N/A	N/A	DWS Length (in)	N/A
			N/A	Landing X Slope (%)	N/A	N/A	DWS Full Width?	N/A
Surveyor Notes:	N/A		N/A	Landing Curb? (Y/N)	N/A	N/A	DWS Offset (in)	N/A
			N/A	Shared Landing?	N/A
