Access Compliance Report

Public Rights-of-Way

(Curb Ramps)

Intersection ID: 52311	Main Street: IMPATIEN_DR	Cross Street: LUPINE_CT	Location: NE
ADA ID: AD69AE7BFBC7	Ramp Type: PerpDiag	Initial Pass/Fail: Fail	Overall Compliance: No
		Severity Score: 10

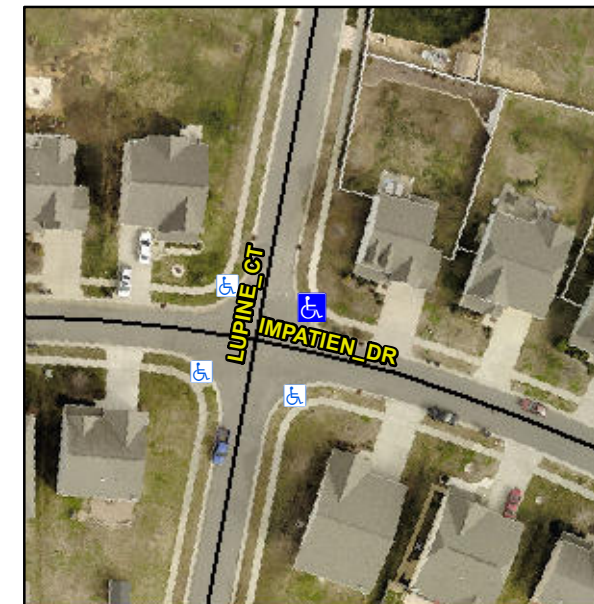
Not Found, R304.5.1, R304.5.3

Compliance	Description	Data	Compliance	Description	Data
N/A	Ramp Length (in)	71.5	Yes	Ramp Slope (%)	5.2
No	Ramp Width (in)	47.0	No	Ramp XSlope (%)	2.8
N/A	Flare Type LT	N/A	N/A	Flare Type RT	N/A
N/A	Flare Slope LT (%)	N/A	N/A	Flare Slope RT (%)	N/A
N/A	Flare Traversable LT?	N/A	N/A	Flare Traversable RT?	N/A
N/A	Landing Length (in)	N/A	N/A	DWS Provided?	N/A
N/A	Landing Width (in)	N/A	N/A	DWS Contrast?	N/A
N/A	Landing Slope (%)	N/A	N/A	DWS Length (in)	N/A
N/A	Landing X Slope (%)	N/A	N/A	DWS Full Width?	N/A
N/A	Landing Curb? (Y/N)	N/A	N/A	DWS Offset (in)	N/A
N/A	Shared Landing?	N/A			
N/A	Gutter Ponding?	N/A	N/A	Gutter Slope (%)	N/A
N/A	Gutter Lip Ht (in)	1.5	N/A	Gutter X Slope (%)	N/A
N/A	Painted X Walk1?	No	N/A	Painted X Walk2?	No
	X Walk 1 Direction	To W		X Walk 2 Direction	To S
N/A	X Walk 1 Width (in)	N/A	N/A	X Walk 2 Width (in)	N/A
	X Walk 1 Slope (%)	3.4		X Walk 2 Slope (%)	2.5
	X Walk 1 X Slope (%)	0.2		X Walk 2 X Slope (%)	1.2

N/A	Ramp inside XWalk1?	N/A	N/A	Ramp inside XWalk2?	N/A
	Road Slope (%)	1.2	N/A	Clear Space?	N/A
	Road X Slope (%)	1.6	N/A	Clear Space to XWalk (in)	N/A
N/A	Any Obstructions?	N/A	N/A	Storm Grate/Utility Hazard?	N/A
	Obstruction Type			Storm Grate/Utility Type	
		N/A			N/A
		Yes		Surface Condition? (G/P)	Good

Remove & Replace Curb Ramp With Two New Directional Ramps or Equivalent.
