# Access Compliance Report

## Public Rights-of-Way

### (Curb Ramps)

Intersection ID: 14710	Main Street: LYNDHURST_AV	Cross Street: MCDONALD_AV	Location: S
ADA ID: AD75CC889DD7	Ramp Type: Perp	Initial Pass/Fail: Fail	Overall Compliance: No
		Severity Score: 12.5

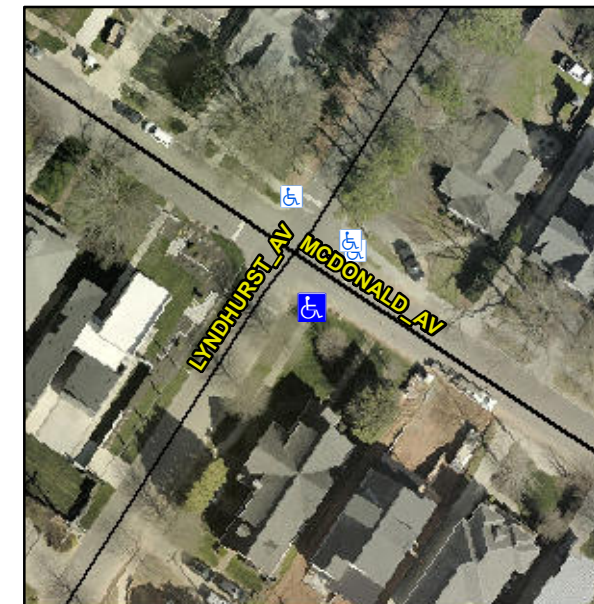
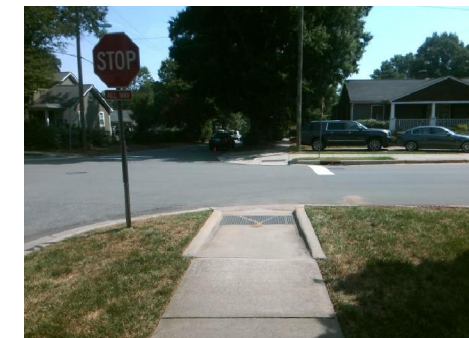
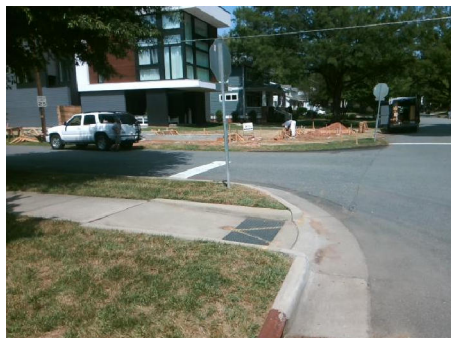
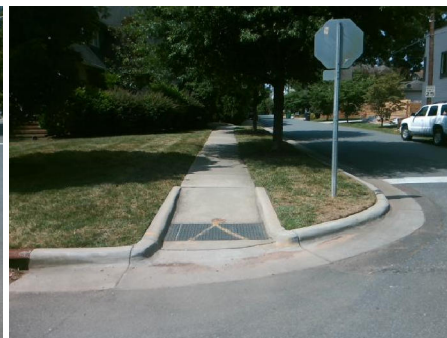
**Not Found, R304.2.2**

Compliance	Description	Data	Compliance	Description	Data
N/A	Ramp Length (in)	106.0	No	Ramp Slope (%)	11.1
Yes	Ramp Width (in)	55.0	Yes	Ramp XSlope (%)	1.3
N/A	Flare Type LT	N/A	N/A	Flare Type RT	N/A
N/A	Flare Slope LT (%)	N/A	N/A	Flare Slope RT (%)	N/A
N/A	Flare Traversable LT?	N/A	N/A	Flare Traversable RT?	N/A
N/A	Landing Length (in)	N/A	N/A	DWS Provided?	N/A
N/A	Landing Width (in)	N/A	N/A	DWS Contrast?	N/A
N/A	Landing Slope (%)	N/A	N/A	DWS Length (in)	N/A
N/A	Landing X Slope (%)	N/A	N/A	DWS Full Width?	N/A
N/A	Landing Curb? (Y/N)	N/A	N/A	DWS Offset (in)	N/A
N/A	Shared Landing?	N/A			
N/A	Gutter Ponding?	N/A	N/A	Gutter Slope (%)	N/A
N/A	Gutter Lip Ht (in)	N/A	N/A	Gutter X Slope (%)	N/A
N/A	Painted X Walk1?	No	N/A	Painted X Walk2?	N/A
	X Walk 1 Direction	To NE		X Walk 2 Direction	N/A
N/A	X Walk 1 Width (in)	N/A	N/A	X Walk 2 Width (in)	N/A
	X Walk 1 Slope (%)	0.8		X Walk 2 Slope (%)	N/A
	X Walk 1 X Slope (%)	0.0		X Walk 2 X Slope (%)	N/A

**Remove & Replace Entire Ramp.**

Total Cost: \$ 1850.00
