Access Compliance Report

Public Rights-of-Way

(Curb Ramps)

Intersection ID: N/A	Main Street: ROCKY_RIVER_RD	Cross Street: JOHN_RUSSELL_RD	Location: SW
ADA ID: AD77B714C4F3	Ramp Type: Perp	Initial Pass/Fail: Fail	Overall Compliance: No
Severity Score: 21.25			
Codes/Mitigation Info/Possible Solution		Field Measurements/Component Compliance

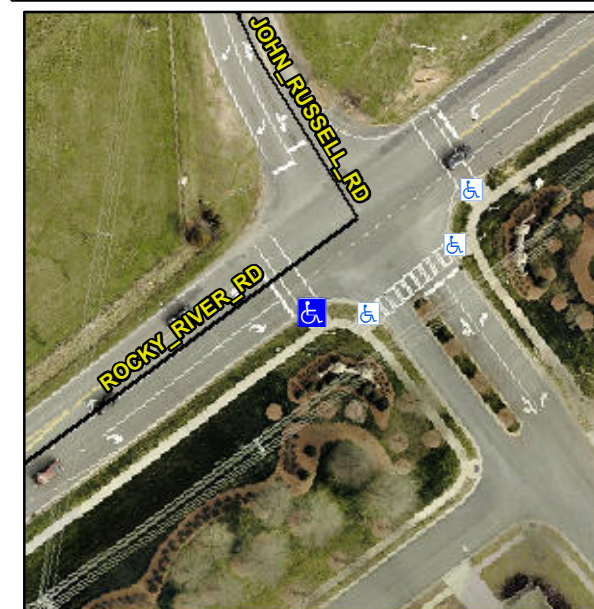
Not Found, R304.5.1, R304.2.2

Compliance	Description	Data	Compliance	Description	Data
N/A	Ramp Length (in)	96.0	No	Ramp Slope (%)	11.0
No	Ramp Width (in)	47.0	Yes	Ramp XSlope (%)	0.5
N/A	Flare Type LT	N/A	N/A	Flare Type RT	N/A
N/A	Flare Slope LT (%)	N/A	N/A	Flare Slope RT (%)	N/A
N/A	Flare Traversable LT?	N/A	N/A	Flare Traversable RT?	N/A
N/A	Landing Length (in)	N/A	N/A	DWS Provided?	N/A
N/A	Landing Width (in)	N/A	N/A	DWS Contrast?	N/A
N/A	Landing Slope (%)	N/A	N/A	DWS Length (in)	N/A
N/A	Landing X Slope (%)	N/A	N/A	DWS Full Width?	N/A
N/A	Landing Curb? (Y/N)	N/A	N/A	DWS Offset (in)	N/A
N/A	Shared Landing?	N/A			
N/A	Gutter Ponding?	N/A	N/A	Gutter Slope (%)	N/A
N/A	Gutter Lip Ht (in)	N/A	N/A	Gutter X Slope (%)	N/A
N/A	Painted X Walk1?	Yes	N/A	Painted X Walk2?	N/A
	X Walk 1 Direction	To NW		X Walk 2 Direction	N/A
N/A	X Walk 1 Width (in)	112.0	N/A	X Walk 2 Width (in)	N/A
	X Walk 1 Slope (%)	2.0		X Walk 2 Slope (%)	N/A
	X Walk 1 X Slope (%)	0.3		X Walk 2 X Slope (%)	N/A

N/A	Ramp inside XWalk1?	Yes	N/A	Ramp inside XWalk2?	N/A
	Road Slope (%)	N/A	N/A	Clear Space?	N/A
	Road X Slope (%)	N/A	N/A	Clear Space to XWalk (in)	N/A
N/A	Any Obstructions?	N/A	N/A	Storm Grate/Utility Hazard?	N/A
	Obstruction Type			Storm Grate/Utility Type	
		N/A			N/A
		Yes		Surface Condition? (G/P)	Good

Possible Solutions:

Remove & Replace Entire Ramp.
