# Access Compliance Report

## Public Rights-of-Way

### (Curb Ramps)

Intersection ID: 47275	Main Street: CARRINGTON_FOREST_LN	Cross Street: GREYSTONE_PARK_LN	Location: SE
ADA ID: AD8DEC191873	Ramp Type: Perp	Initial Pass/Fail: Fail	Overall Compliance: No
Severity Score: 21.25			
Codes/Mitigation Info/Possible Solution		Field Measurements/Component Compliance

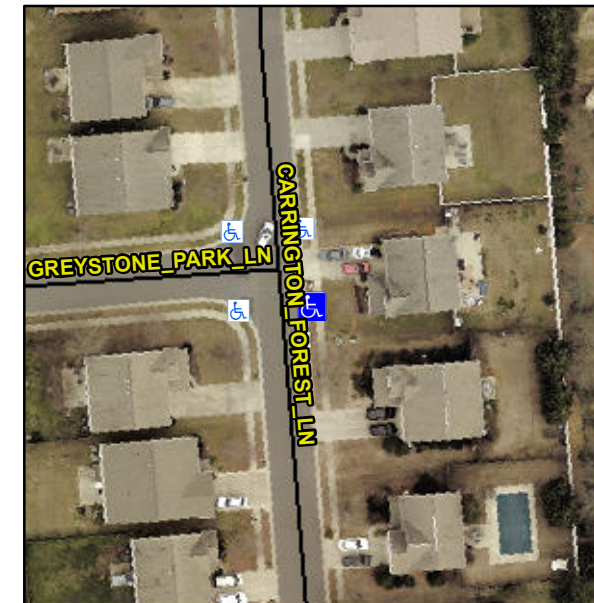
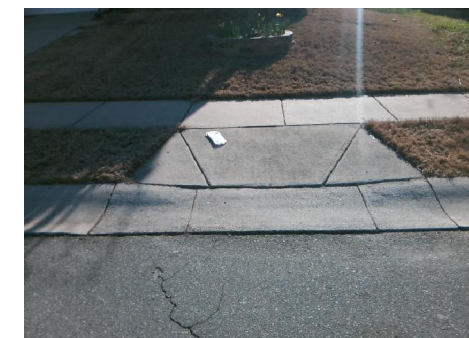
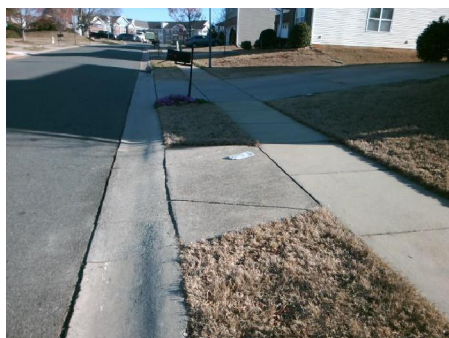
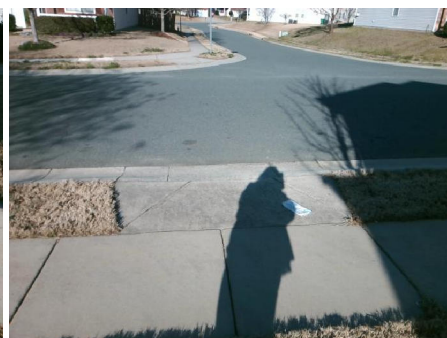
**Not Found, R304.5.1, R304.2.2**

Compliance	Description	Data	Compliance	Description	Data
N/A	Ramp Length (in)	49.0	No	Ramp Slope (%)	9.6
No	Ramp Width (in)	39.0	Yes	Ramp XSlope (%)	1.6
N/A	Flare Type LT	N/A	N/A	Flare Type RT	N/A
N/A	Flare Slope LT (%)	N/A	N/A	Flare Slope RT (%)	N/A
N/A	Flare Traversable LT?	N/A	N/A	Flare Traversable RT?	N/A
N/A	Landing Length (in)	N/A	N/A	DWS Provided?	N/A
N/A	Landing Width (in)	N/A	N/A	DWS Contrast?	N/A
N/A	Landing Slope (%)	N/A	N/A	DWS Length (in)	N/A
N/A	Landing X Slope (%)	N/A	N/A	DWS Full Width?	N/A
N/A	Landing Curb? (Y/N)	N/A	N/A	DWS Offset (in)	N/A
N/A	Shared Landing?	N/A			
N/A	Gutter Ponding?	N/A	N/A	Gutter Slope (%)	N/A
N/A	Gutter Lip Ht (in)	N/A	N/A	Gutter X Slope (%)	N/A
N/A	Painted X Walk1?	No	N/A	Painted X Walk2?	N/A
	X Walk 1 Direction	To W		X Walk 2 Direction	N/A
N/A	X Walk 1 Width (in)	N/A	N/A	X Walk 2 Width (in)	N/A
	X Walk 1 Slope (%)	3.5		X Walk 2 Slope (%)	N/A
	X Walk 1 X Slope (%)	3.7		X Walk 2 X Slope (%)	N/A

N/A	Ramp inside XWalk1?	N/A	N/A	Ramp inside XWalk2?	N/A
	Road Slope (%)	N/A	N/A	Clear Space?	N/A
	Road X Slope (%)	N/A	N/A	Clear Space to XWalk (in)	N/A
N/A	Any Obstructions?	N/A	N/A	Storm Grate/Utility Hazard?	N/A
	Obstruction Type			Storm Grate/Utility Type	
		N/A			N/A
			Yes	Surface Condition? (G/P)	Good

**Remove & Replace Entire Ramp.**

Total Cost: \$ 1850.00
