Access Compliance Report

Public Rights-of-Way

(Curb Ramps)

Intersection ID: N/A	Main Street: CRAIGHEAD_RD	Cross Street: N/A	Location: SW
ADA ID: ADA99DB96A51	Ramp Type: Combination2Diag	Initial Pass/Fail: Fail	Overall Compliance: No
Codes/Mitigation Info/Possible Solution		Field Measurements/Component Compliance	
Severity Score: 15

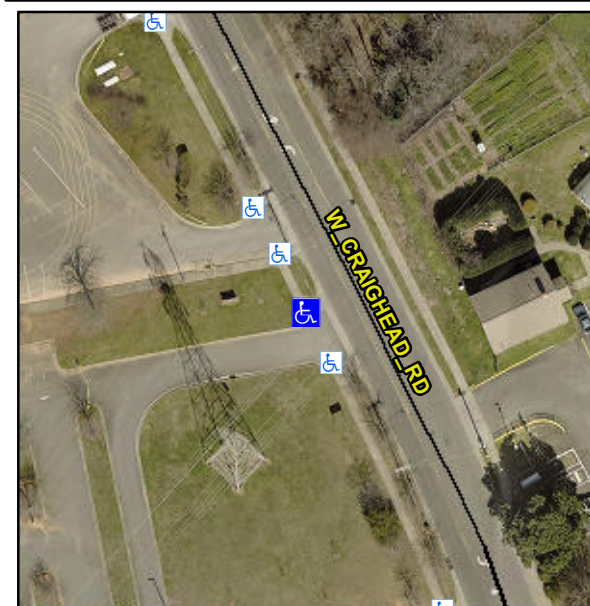
Not Found, R304.2.2, R304.5.3, R302.7

Compliance	Description	Data	Compliance	Description	Data
N/A	Ramp Length LT (in)	N/A	N/A	Ramp Length RT (in)	48.0
N/A	Ramp Width LT (in)	N/A	Yes	Ramp Width RT (in)	64.0
N/A	Ramp Slope LT (%)	N/A	Yes	Ramp Slope RT (%)	7.3
N/A	Ramp XSlope LT (%)	N/A	No	Ramp XSlope RT (%)	4.8
N/A	Ramp Length (in)	49.0	No	Ramp Slope (%)	13.3
Yes	Ramp Width (in)	48.0	Yes	Ramp XSlope (%)	1.5
N/A	Flare Type LT	N/A	N/A	Flare Type RT	N/A
N/A	Flare Slope LT (%)	N/A	N/A	Flare Slope RT (%)	N/A
N/A	Flare Traversable LT?	N/A	N/A	Flare Traversable RT?	N/A
N/A	Landing Length (in)	N/A	N/A	DWS Provided?	N/A
N/A	Landing Width (in)	N/A	N/A	DWS Contrast?	N/A
N/A	Landing Slope (%)	N/A	N/A	DWS Length (in)	N/A
N/A	Landing X Slope (%)	N/A	N/A	DWS Full Width?	N/A
N/A	Landing Curb? (Y/N)	N/A	N/A	DWS Offset (in)	N/A
N/A	Shared Landing?	N/A			
N/A	Gutter Ponding?	N/A	N/A	Gutter Slope (%)	N/A
N/A	Gutter Lip Ht (in)	N/A	N/A	Gutter X Slope (%)	N/A
N/A	Painted X Walk1?	No	N/A	Painted X Walk2?	No

X Walk 1 Direction	To S		X Walk 2 Direction	To E
	X Walk 1 Width (in)	N/A		X Walk 2 Width (in)	N/A
	X Walk 1 Slope (%)	3.2		X Walk 2 Slope (%)	2.4
	X Walk 1 X Slope (%)	2.0		X Walk 2 X Slope (%)	4.4
N/A	Ramp inside XWalk1?	N/A	N/A	Ramp inside XWalk2?	N/A
	Road Slope (%)	1.4		Clear Space?	N/A
	Road X Slope (%)	4.1	N/A	Clear Space to XWalk (in)	N/A
			N/A	Any Obstruction?	N/A
				Obstruction Type	N/A
			N/A	Storm Grate/Utility Hazard?	N/A
				Storm Grate/Utility Type	N/A
No	Surface Condition? (G/P)	Poor			
	Curb Slope (%)	11.3

Remove & Replace Curb Ramp With Two New Directional Ramps or Equivalent.
