Intersection ID: 14615 Main Street: MCMANUS DR **Cross Street: ROSEHAVEN DR** Location: SE ADA ID: ADAA09DC4770 Ramp Type: BlendTrans1 Initial Pass/Fail: Fail **Overall Compliance: No Severity Score:** 8.75

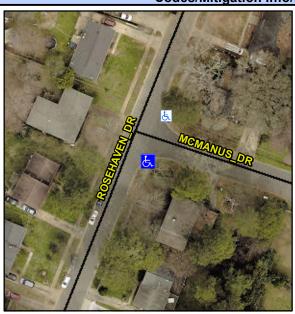
Street 1 Name Stop Condition-Street 1 Street 2 Name Stop Condition-Street 2 Possible Solutions: Remove & Replace Curb Ramp With Two New Directional Ramps or Equivalent.
