# Access Compliance Report

## Public Rights-of-Way

| Intersection ID: 12508 | Main Street: BELVEDERE_AV | Cross Street: CLUB_RD | Location: S |
| ADA ID: ADC3542248AF | Ramp Type: PerpDiag | Initial Pass/Fail: Fail | Overall Compliance: No |

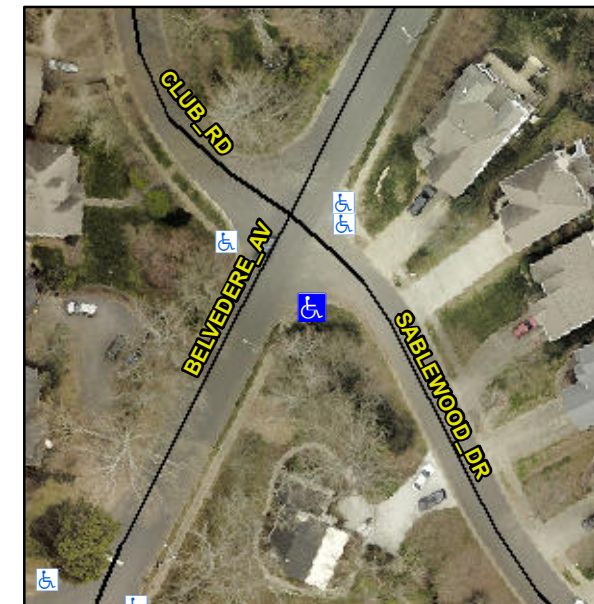
**R304.5.1, R304.2.2, R304.5.3**

| Compliance | Description | Data | Compliance | Description | Data |
|---|---|---|---|---|---|
| N/A | Ramp Length (in) | 57.5 | No | Ramp Slope (%) | 12.4 |
| No | Ramp Width (in) | 44.5 | No | Ramp XSlope (%) | 2.3 |

**Remove & Replace Curb Ramp With Two New Directional Ramps or Equivalent.**

Total Cost: \$ 3200.00
