Access Compliance Report

Public Rights-of-Way

(Curb Ramps)

Intersection ID: 7008	Main Street: MCALLISTER_DR	Cross Street: MERRILL_PL	Location: SE
ADA ID: ADD36BDE2C59	Ramp Type: PerpDiag	Initial Pass/Fail: Fail	Overall Compliance: No
		Severity Score: 8.75

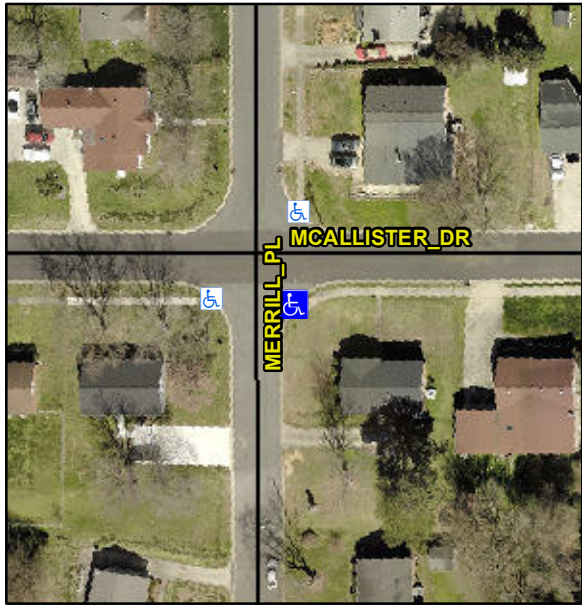
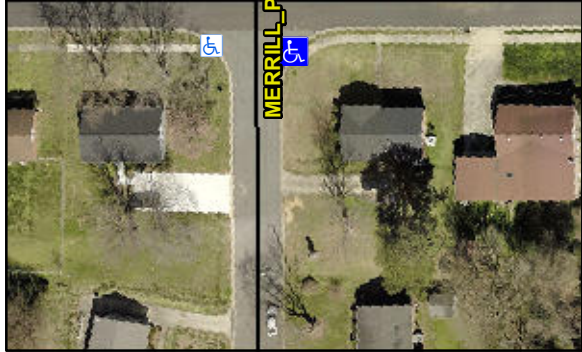
Surveyor Notes:			No			Ramp Width (in)			44.0						
			N/A			N/A			Flare Type LT			N/A						
<p>Street 1 Name</p> <p>Stop Condition-Street 2</p> <p>Street 2 Name</p> <p>Stop Condition-Street 1</p>			PROW/ADA:			N/A			N/A			Flare Slope LT (%)			N/A			
			Not Found, R304.5.1			N/A			N/A			Flare Traversable LT?			N/A			
<p>Total Cost:</p>									N/A			Landing Length (in)			N/A			
									N/A			Landing Width (in)			N/A			
									N/A			Landing Slope (%)			N/A			
									N/A			Landing X Slope (%)			N/A			
									N/A			Landing Curb? (Y/N)			N/A			
									N/A			Shared Landing?			N/A			
									N/A			Gutter Ponding?			N/A

N/A			Gutter Lip Ht (in)			N/A			
									N/A			Painted X Walk1?			No			
									To N			X Walk 2 Direction			To W			
									N/A			X Walk 1 Width (in)			N/A			
												X Walk 2 Width (in)			N/A			
												X Walk 1 Slope (%)			4.4			
												X Walk 2 Slope (%)			4.6			
												X Walk 1 X Slope (%)			6.3			
												X Walk 2 X Slope (%)			4.6			
									N/A			Ramp inside XWalk1?			N/A			
									N/A			Ramp inside XWalk2?			N/A

0.9			Clear Space?			N/A			
									9.0			Clear Space to XWalk (in)			N/A			
									N/A			Any Obstructions?			N/A			
												Storm Grate/Utility Hazard?			N/A			
												Obstruction Type						
									N/A			Storm Grate/Utility Type			N/A			
												Yes			Surface Condition? (G/P)		Good

Possible Solutions:			Compliance			Description			Data						
			Remove & Replace Curb Ramp With Two New Directional Ramps or Equivalent.			N/A			Ramp Length (in)			32.5
