Access Compliance Report

Public Rights-of-Way

(Curb Ramps)

Intersection ID: 23104	Main Street: PENSFORD_LN	Cross Street: LYNBRIDGE_DR	Location: SE
ADA ID: ADD68EF91C64	Ramp Type: PerpDiag	Initial Pass/Fail: Fail	Overall Compliance: No
Severity Score: 46.25			
Codes/Mitigation Info/Possible Solution		Field Measurements/Component Compliance

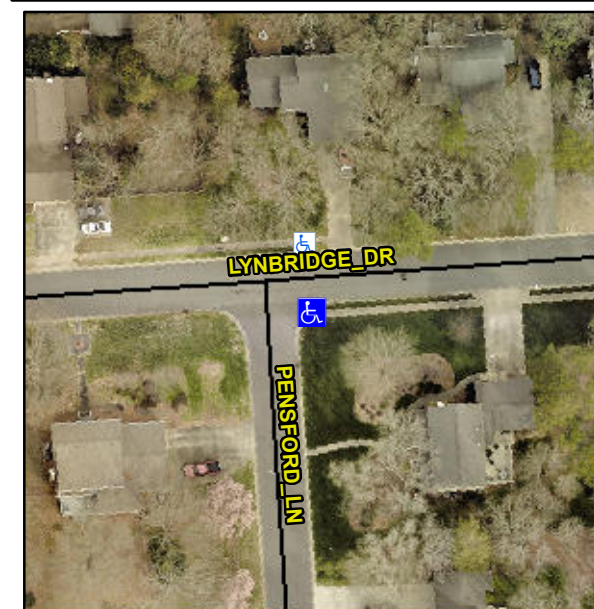
Compliance	Description	Data	Compliance	Description	Data
N/A	Ramp Length (in)	38.5	No	Ramp Slope (%)	13.6
No	Ramp Width (in)	39.0	No	Ramp XSlope (%)	6.0
N/A	Flare Type LT	N/A	N/A	Flare Type RT	N/A
N/A	Flare Slope LT (%)	N/A	N/A	Flare Slope RT (%)	N/A
N/A	Flare Traversable LT?	N/A	N/A	Flare Traversable RT?	N/A
N/A	Landing Length (in)	N/A	N/A	DWS Provided?	N/A
N/A	Landing Width (in)	N/A	N/A	DWS Contrast?	N/A
N/A	Landing Slope (%)	N/A	N/A	DWS Length (in)	N/A
N/A	Landing X Slope (%)	N/A	N/A	DWS Full Width?	N/A
N/A	Landing Curb? (Y/N)	N/A	N/A	DWS Offset (in)	N/A
N/A	Shared Landing?	N/A			
N/A	Gutter Ponding?	N/A	N/A	Gutter Slope (%)	N/A
N/A	Gutter Lip Ht (in)	N/A	N/A	Gutter X Slope (%)	N/A
N/A	Painted X Walk1?	No	N/A	Painted X Walk2?	No
	X Walk 1 Direction	To N		X Walk 2 Direction	To W
N/A	X Walk 1 Width (in)	N/A	N/A	X Walk 2 Width (in)	N/A
	X Walk 1 Slope (%)	1.2		X Walk 2 Slope (%)	4.3
	X Walk 1 X Slope (%)	5.6		X Walk 2 X Slope (%)	0.0

N/A	Ramp inside XWalk1?	N/A	N/A	Ramp inside XWalk2?	N/A
	Road Slope (%)	3.9	N/A	Clear Space?	N/A
	Road X Slope (%)	2.5	N/A	Clear Space to XWalk (in)	N/A
N/A	Any Obstructions?	N/A	N/A	Storm Grate/Utility Hazard?	N/A
	Obstruction Type			Storm Grate/Utility Type	
		N/A			N/A
			Yes	Surface Condition? (G/P)	Good

Possible Solutions:

Remove & Replace Curb Ramp With Two New Directional Ramps or Equivalent.
