## **Access Compliance Report Public Rights-of-Way** (Curb Ramps)

Intersection ID: 12493 Main Street: BELVEDERE\_AV **Cross Street: WINTER\_ST** Location: NW **ADA ID: ADD75F937D01**

**Overall Compliance: No** Ramp Type: Perp Initial Pass/Fail: Pass **Severity Score:**

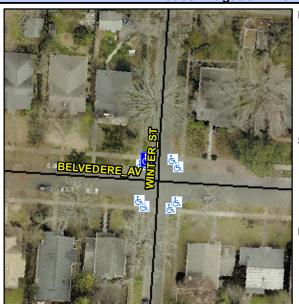
Field Measurements/Component Compliance						
Comp	liance Description	Data	Comp	oliance Description	Data	
N/A	Ramp Length (in)	109.5	Yes	Ramp Slope (%)	6.8	
Yes	Ramp Width (in)	48.0	Yes	Ramp XSlope (%)	1.6	
N/A	Flare Type LT	Sloped	N/A	Flare Type RT	N/A	
N/A	Flare Slope LT (%)	8.2	N/A	Flare Slope RT (%)	2.2	
N/A	Flare Traversable LT?	No	N/A	Flare Traversable RT?	No	
Yes	Landing Length (in)	48.0	Yes	DWS Provided?	Yes	
Yes	Landing Width (in)	58.0	Yes	DWS Contrast?	Yes	
No	Landing Slope (%)	6.4	Yes	DWS Length (in)	24.5	
No	Landing X Slope (%)	3.4	Yes	DWS Full Width?	Yes	
N/A	Landing Curb? (Y/N)	No	Yes	DWS Offset (in)	0.0	
N/A	Shared Landing?	Yes				
Yes	Gutter Ponding?	No	Yes	Gutter Slope (%)	1.1	
Yes	Gutter Lip Ht (in)	0.0	Yes	Gutter X Slope (%)	0.9	
N/A	Painted X Walk1?	No	N/A	Painted X Walk2?	N/A	
	X Walk 1 Direction	To E		X Walk 2 Direction	N/A	
N/A	X Walk 1 Width (in)	N/A	N/A	X Walk 2 Width (in)	N/A	
	X Walk 1 Slope (%)	0.9		X Walk 2 Slope (%)	N/A

X Walk 1 X Slope (%)	1.1		X Walk 2 X Slope (%)	N/A	
N/A	Ramp inside XWalk1?	N/A	N/A	Ramp inside XWalk2?	N/A	
	Road Slope (%)	N/A	N/A	Clear Space?	Yes	
	Road X Slope (%)	N/A	N/A	Clear Space to XWalk (in)	N/A	
Yes	Any Obstructions?	No	Yes	Storm Grate/Utility Hazard?	No	
	Obstruction Type			Storm Grate/Utility Type		
		N/A			N/A	
			Yes	Surface Condition? (G/P)	Good

Possible Solutions:	<u>c</u>
Remove & Replace Landing.	N
	Y
	N
	N
	N
	Y
Surveyor Notes:	Y
N/A	N
	N
	N
	N
PROW/ADA:	Y
R304.2.2-Perp, R304.3.2-Para,	Ye
R304.5.3	N
	N
	N
