Access Compliance Report

Public Rights-of-Way

(Curb Ramps)

Intersection ID: 3795	Main Street: FOUNTAINGROVE_DR	Cross Street: TOWTON_CT	Location: E
ADA ID: ADDCE20DE5F6	Ramp Type: Perp	Initial Pass/Fail: Fail	Overall Compliance: No
Severity Score: 8.75			
Codes/Mitigation Info/Possible Solution		Field Measurements/Component Compliance

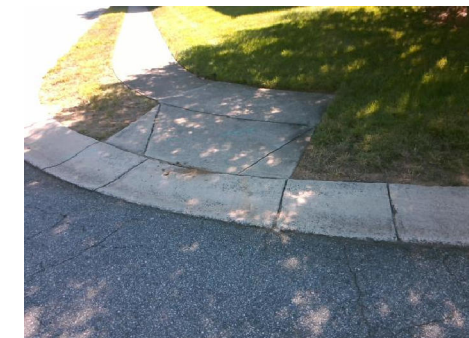
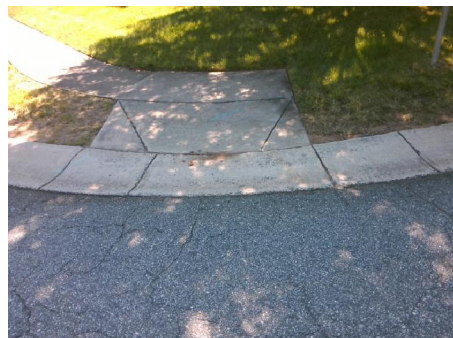
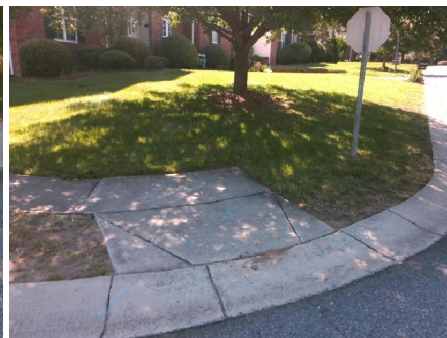
Compliance	Description	Data	Compliance	Description	Data
N/A	Ramp Length (in)	49.0	Yes	Ramp Slope (%)	6.0
No	Ramp Width (in)	43.0	Yes	Ramp XSlope (%)	1.5
N/A	Flare Type LT	N/A	N/A	Flare Type RT	N/A
N/A	Flare Slope LT (%)	N/A	N/A	Flare Slope RT (%)	N/A
N/A	Flare Traversable LT?	N/A	N/A	Flare Traversable RT?	N/A
N/A	Landing Length (in)	N/A	N/A	DWS Provided?	N/A
N/A	Landing Width (in)	N/A	N/A	DWS Contrast?	N/A
N/A	Landing Slope (%)	N/A	N/A	DWS Length (in)	N/A
N/A	Landing X Slope (%)	N/A	N/A	DWS Full Width?	N/A
N/A	Landing Curb? (Y/N)	N/A	N/A	DWS Offset (in)	N/A
N/A	Shared Landing?	N/A			
N/A	Gutter Ponding?	N/A	N/A	Gutter Slope (%)	N/A
N/A	Gutter Lip Ht (in)	N/A	N/A	Gutter X Slope (%)	N/A
N/A	Painted X Walk1?	No	N/A	Painted X Walk2?	N/A
	X Walk 1 Direction	To SW		X Walk 2 Direction	N/A
N/A	X Walk 1 Width (in)	N/A	N/A	X Walk 2 Width (in)	N/A
	X Walk 1 Slope (%)	1.9		X Walk 2 Slope (%)	N/A
	X Walk 1 X Slope (%)	4.3		X Walk 2 X Slope (%)	N/A

N/A	Ramp inside XWalk1?	N/A	N/A	Ramp inside XWalk2?	N/A
	Road Slope (%)	N/A	N/A	Clear Space?	N/A
	Road X Slope (%)	N/A	N/A	Clear Space to XWalk (in)	N/A
N/A	Any Obstructions?	N/A	N/A	Storm Grate/Utility Hazard?	N/A
	Obstruction Type			Storm Grate/Utility Type	
		N/A			N/A
		Yes		Surface Condition? (G/P)	Good

Possible Solutions:

Remove & Replace Entire Ramp.
