Access Compliance Report Public Rights-of-Way (Curb Ramps)

Intersection ID: 2733 Main Street: CARDINAL_POINT_RD Cross Street: SWEETFIELD_DR Location: N

ADA ID: ADE2043CE263 Ramp Type: Perp Initial Pass/Fail: Fail Overall Compliance: No Severity Score: 1.25

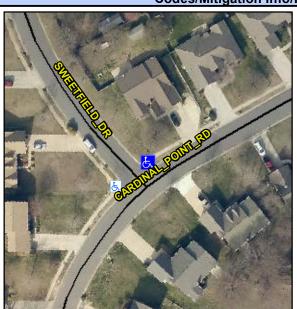
Not Found, R304.5.3

| Field Measurements/Component Compliance | | | | | | |
|---|---|---|---|---|---|---|
| | Yes | Ramp Width (in) | 127.0 | No | Ramp XSlope (%) | 3.8 |

Remove & Replace Entire Ramp.

Total Cost: \$ 1850.00
