Access Compliance Report

Public Rights-of-Way

(Curb Ramps)

Intersection ID: 5009	Main Street: OAK_DR	Cross Street: FOX_POINT_DR	Location: SE
ADA ID: ADE24FC85DC5	Ramp Type: PerpDiag	Initial Pass/Fail: Fail	Overall Compliance: No
Severity Score: 32.5			
Codes/Mitigation Info/Possible Solution		Field Measurements/Component Compliance

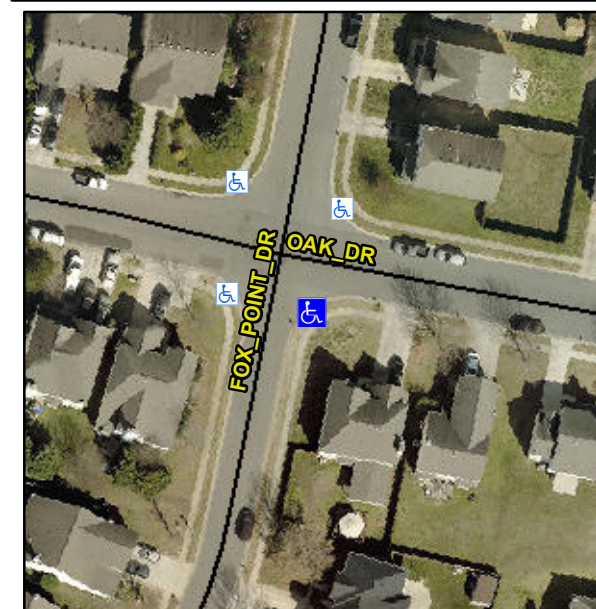
Compliance	Description	Data	Compliance	Description	Data
N/A	Ramp Length (in)	48.0	Yes	Ramp Slope (%)	6.2
No	Ramp Width (in)	34.5	Yes	Ramp XSlope (%)	1.6
N/A	Flare Type LT	N/A	N/A	Flare Type RT	N/A
N/A	Flare Slope LT (%)	N/A	N/A	Flare Slope RT (%)	N/A
N/A	Flare Traversable LT?	N/A	N/A	Flare Traversable RT?	N/A
N/A	Landing Length (in)	N/A	N/A	DWS Provided?	N/A
N/A	Landing Width (in)	N/A	N/A	DWS Contrast?	N/A
N/A	Landing Slope (%)	N/A	N/A	DWS Length (in)	N/A
N/A	Landing X Slope (%)	N/A	N/A	DWS Full Width?	N/A
N/A	Landing Curb? (Y/N)	N/A	N/A	DWS Offset (in)	N/A
N/A	Shared Landing?	N/A			
N/A	Gutter Ponding?	N/A	N/A	Gutter Slope (%)	N/A
N/A	Gutter Lip Ht (in)	2.0	N/A	Gutter X Slope (%)	N/A
N/A	Painted X Walk1?	No	N/A	Painted X Walk2?	No
	X Walk 1 Direction	To NE		X Walk 2 Direction	To NW
N/A	X Walk 1 Width (in)	N/A	N/A	X Walk 2 Width (in)	N/A
	X Walk 1 Slope (%)	2.6		X Walk 2 Slope (%)	6.1
	X Walk 1 X Slope (%)	6.2		X Walk 2 X Slope (%)	5.8

N/A	Ramp inside XWalk1?	N/A	N/A	Ramp inside XWalk2?	N/A
	Road Slope (%)	1.5	N/A	Clear Space?	N/A
	Road X Slope (%)	7.6	N/A	Clear Space to XWalk (in)	N/A
N/A	Any Obstructions?	N/A	N/A	Storm Grate/Utility Hazard?	N/A
	Obstruction Type			Storm Grate/Utility Type	
		N/A			N/A
		No		Surface Condition? (G/P)	Poor

Remove & Replace Curb Ramp With Two New Directional Ramps or Equivalent.

R304.5.1, R302.7
