Intersection ID: 9326	Main Street: FAIRMONT_ST	Cross Street: OAKLAWN_AV	Location:	NW
ADA ID: ADE9701B253E	Ramp Type: Perp	Initial Pass/Fail: Fail	Overall Compliance: No	Severity Score: 33.75

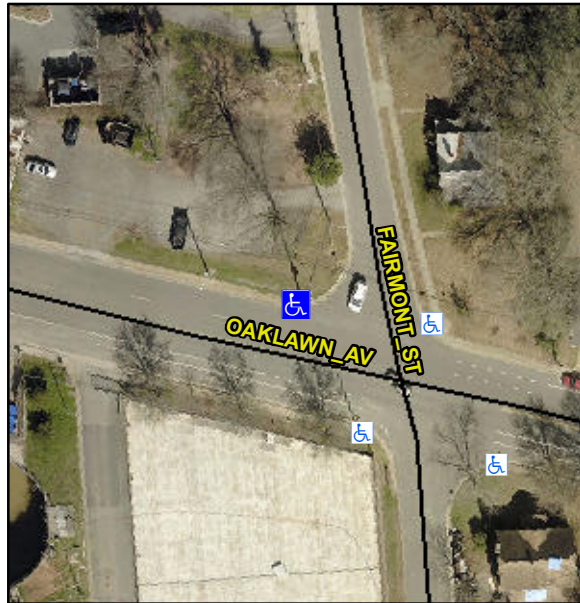
**Not Found, R304.5.1, R304.2.2**

Possible Solutions:			Compliance	Description	Data	Compliance	Description	Data
<b>Remove &amp; Replace Entire Ramp.</b>			N/A	Ramp Length (in)	29.0	No	Ramp Slope (%)	15.9
			No	Ramp Width (in)	36.0	Yes	Ramp XSlope (%)	1.9
			N/A	Flare Type LT	N/A	N/A	Flare Type RT	N/A
			N/A	Flare Slope LT (%)	N/A	N/A	Flare Slope RT (%)	N/A
			N/A	Flare Traversable LT?	N/A	N/A	Flare Traversable RT?	N/A
			N/A	Landing Length (in)	N/A	N/A	DWS Provided?	N/A
			N/A	Landing Width (in)	N/A	N/A	DWS Contrast?	N/A
			N/A	Landing Slope (%)	N/A	N/A	DWS Length (in)	N/A
			N/A	Landing X Slope (%)	N/A	N/A	DWS Full Width?	N/A
			N/A	Landing Curb? (Y/N)	N/A	N/A	DWS Offset (in)	N/A
Surveyor Notes: <b>N/A</b>			N/A	Shared Landing?	N/A			
			N/A	Gutter Ponding?	N/A	N/A	Gutter Slope (%)	N/A
			N/A	Gutter Lip Ht (in)	N/A	N/A	Gutter X Slope (%)	N/A
			N/A	Painted X Walk1?	No	N/A	Painted X Walk2?	N/A
				X Walk 1 Direction	To SE		X Walk 2 Direction	N/A

N/A	X Walk 1 Width (in)	N/A	N/A	X Walk 2 Width (in)	N/A
				X Walk 1 Slope (%)	1.6		X Walk 2 Slope (%)	N/A
				X Walk 1 X Slope (%)	2.3		X Walk 2 X Slope (%)	N/A
			N/A	Ramp inside XWalk1?	N/A	N/A	Ramp inside XWalk2?	N/A
				Road Slope (%)	N/A	N/A	Clear Space?	N/A
PROW/ADA: <b>Not Found, R304.5.1, R304.2.2</b>				Road X Slope (%)	N/A	N/A	Clear Space to XWalk (in)	N/A
			N/A	Any Obstructions?	N/A	N/A	Storm Grate/Utility Hazard?	N/A
				Obstruction Type			Storm Grate/Utility Type	
					N/A			N/A
						Yes	Surface Condition? (G/P)	Good
Total Cost:			\$	1850.00

### Remove & Replace Entire Ramp.
